Service Bulletin

Bulletin No.: PI0965A

Subject: Squeaking/Creaking Type Noise Heard When Using Clutch Pedal

Models: 2012-2013 Chevrolet Cruze Equipped with Manual Transmission (RPOs MF3, MR5, MZ0)
2012-2013 Chevrolet Sonic Equipped with Manual Transmission (RPOs MZ4, M26)

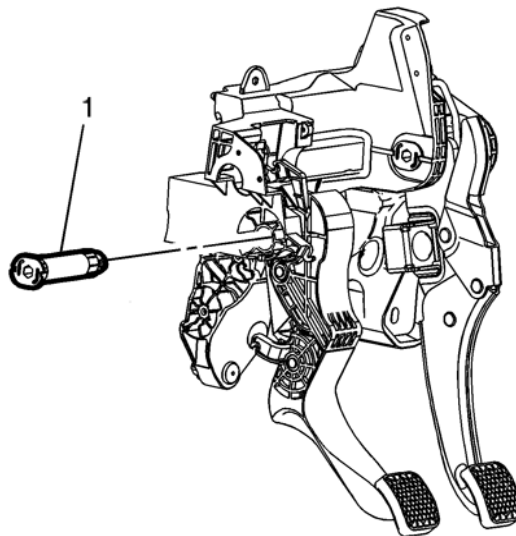
3412540

Some customers may comment on a squeaking/creaking type noise heard when using the clutch pedal.

This may be caused from lack of or no lubrication on the clutch pedal pin (1) shown in the illustration above.
