# Service Bulletin

Bulletin No.: PI0970A

**Subject:** Difficult to Engage Clamp(s) When Installing Soft Roll-up Tonneau Cover

**Models:** 2014 Chevrolet Silverado 1500  
2015 Chevrolet Silverado  
2014 GMC Sierra 1500  
2015 GMC Sierra  
Excluding 8 Foot - Long Box Vehicles

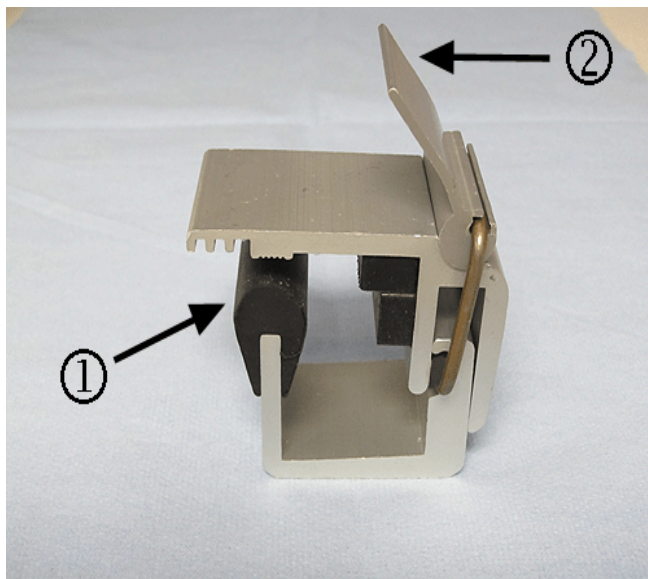
3436173

During installation of the soft tonneau cover, technicians/customers may find it difficult to engage the clamp(s).

The cause of this condition may be the clamp bulb seal (1) not compressing enough to allow the bail (2) on the clamp to rotate to the lock position.

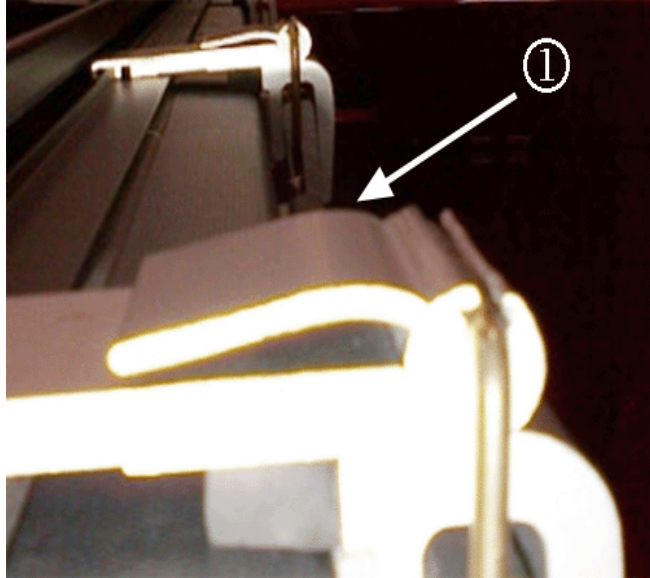
3436180

**Important:** Using excessive force to rotate the bail to lock position could damage the bail. If the bail of the clamp is bent (1) as shown in the graphic above, the clamp assembly will need to be replaced. The proper service part can be found in the Electronic Parts Catalog (EPC).
