Bulletin No.: PI1013B

Subject: A/C Blows Warm Air Intermittently

Models: 2013 Chevrolet Spark

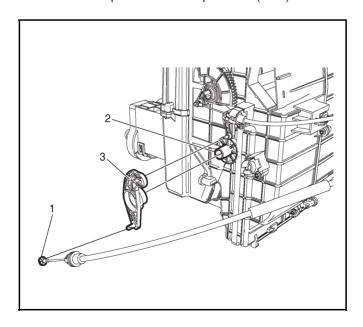
2754800

This condition may be caused by the evaporator freezing to the point that air flow may not be able to pass through the evaporator.

1. Replace the **WHITE** temperature cam link (3) shown in the illustration above with a black colored cam link. Refer to Temperature Valve Link Replacement in SI.

Note: If the temperature cam link is black in color and the vehicle is built prior to November 22, 2012 then this procedure has already been completed.
