# Service Bulletin

Bulletin No.: PI1120A

**Subject:** Creak or Pop Type Noise Coming from Windshield Area During Cold Ambient Temperatures

**Models:** 2011-2014 Chevrolet Equinox  
2011-2014 GMC Terrain

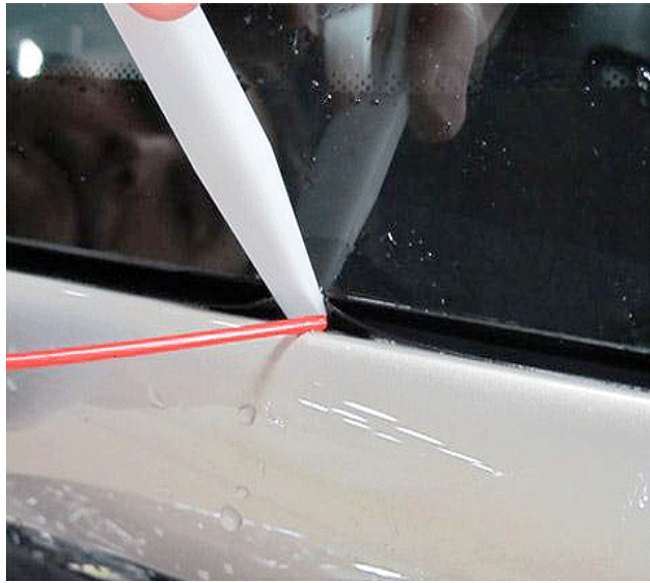
3653600

If the noise is coming from the upper windshield area, the condition may be caused by the windshield exterior molding binding with the windshield glass and/or the windshield opening. If the noise is coming from the base of the windshield, there may be a bind condition between the inside of the windshield glass and the foam seal at the front of the instrument panel upper trim panel.

If the noise is heard in the area surrounding the upper windshield area, spray GM Super Lube up and under the lip of the outside windshield molding.

1. Using a plastic trim stick, lift the windshield molding away from the windshield opening exterior surface.
