Service Bulletin

Bulletin No.: PI1156A

Subject: Outside Door Handle Does Not Open, Lock Rods Loose

Models: 2010-2014 Chevrolet Express
2010-2014 GMC Savana

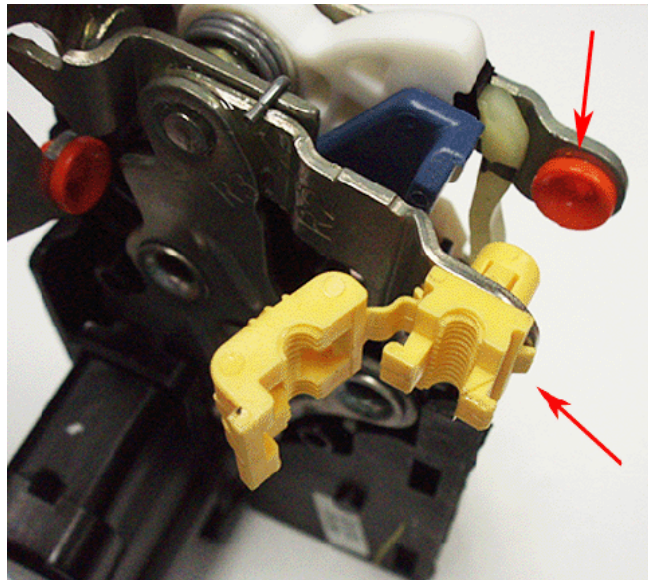
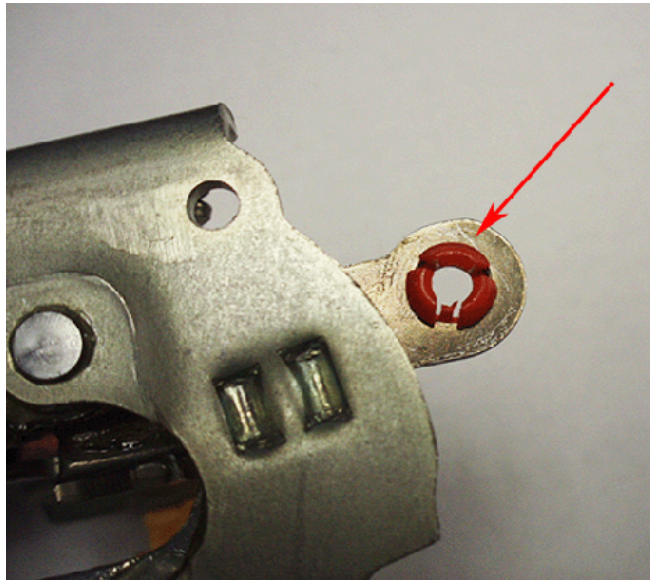
Some customers may comment that the outside door handle does not open the door.

This may be caused by the lock rods becoming loose or disengaged from the clips in the front side door lock (latch).

Technicians should replace the two lock rod clips in the front side door lock (latch) with the parts listed below. Refer to Front Side Door Lock Replacement in SI. Refer to the lock rod clip pictures below. Remove the clips (red and yellow) with a suitable tool and replace.
