# Service Bulletin

Bulletin No.: PI1160A

**Subject:** Water on Front Compartment Floor and/or Musty Odor

**Models:** 2013 Cadillac ATS  
Built Prior to January 3, 2013

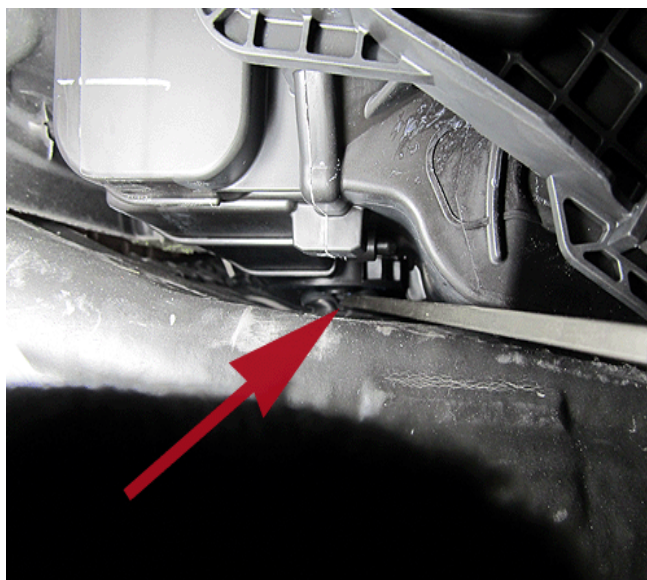
1. Remove the left front floor console extension panel at the front of the console. Refer to Front Floor Console Extension Panel Replacement - Left Side in SI.
2. Remove the left instrument panel lower trim panel insulator (hush panel). Refer to Instrument Panel Lower Trim Panel Insulator Replacement (Left Side) in SI.

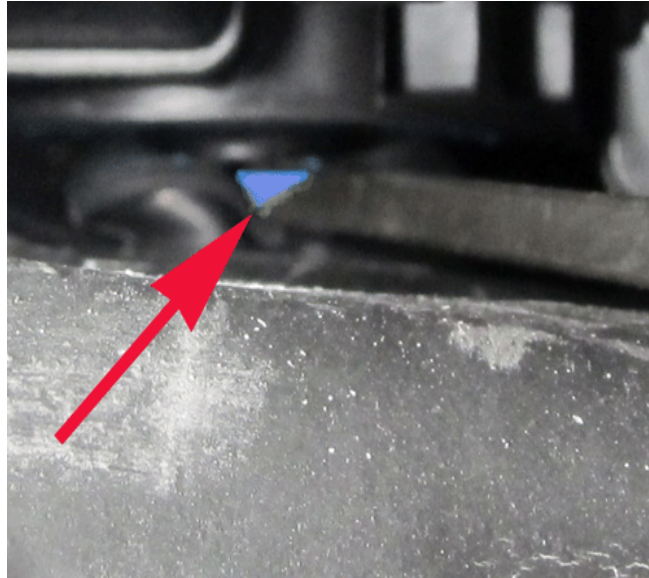
3684483

3. Reposition the seal using a flat-bladed tool as necessary. Inspect the drain assembly for the presence of a white or light blue plastic drain tube.

- ⇒ If the secondary tube is present, replace the drain hose assembly with the revised part listed below. Refer to Air Conditioning Evaporator and Blower Module Drain Hose Replacement in SI. See the Cooling Coil Coating steps below before replacing the drain tube assembly.

**Important:** Remove the secondary white (or blue) drain tube. It is not required with the revised drain tube assembly.
