Service Bulletin

Subject: Water on Front Compartment Floor and/or Musty Odor

Models: 2013 Cadillac ATS Built Prior to January 3, 2013

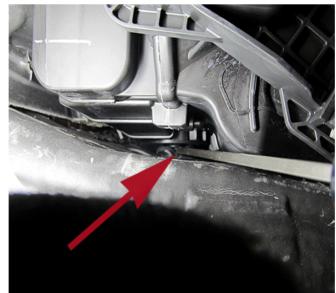
- 1. Remove the left front floor console extension panel at the front of the console. Refer to Front Floor Console Extension Panel Replacement Left Side in SI.
- 2. Remove the left instrument panel lower trim panel insulator (hush panel). Refer to Instrument Panel Lower Trim Panel Insulator Replacement (Left Side) in SI.

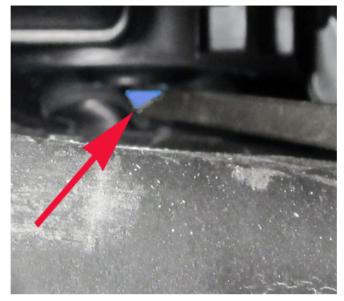
3684483

3. Reposition the seal using a flat-bladed tool as necessary. Inspect the drain assembly for the presence of a white or light blue plastic drain tube.

⇒ If the secondary tube is present, replace the drain hose assembly with the revised part listed below. Refer to Air Conditioning Evaporator and Blower Module Drain Hose Replacement in SI. See the Cooling Coil Coating steps below before replacing the drain tube assembly.

Important: Remove the secondary white (or blue) drain tube. It is not required with the revised drain tube assembly.
