Service Bulletin

Bulletin No.: PI1172A

Subject: Bump on Launch, No Auxiliary Pump Pressure, DTC P2797 Set

Models: 2014-2015 Chevrolet Malibu
Equipped with 6T40 Automatic Transmission (RPO MNH)

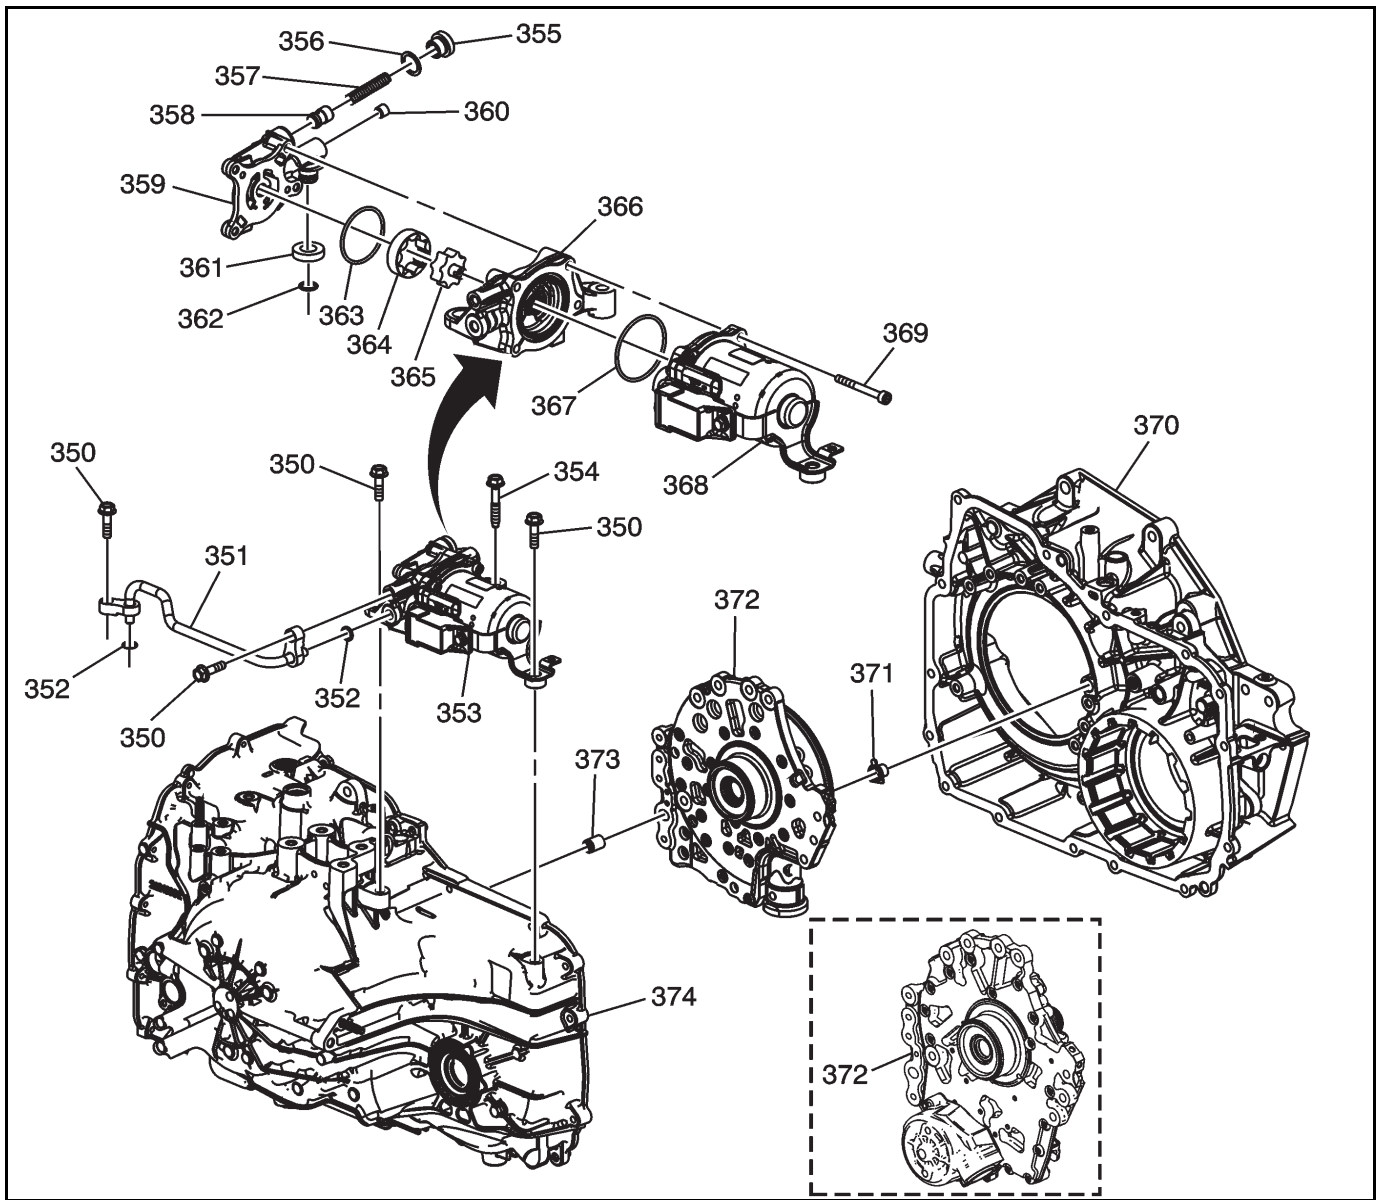
3271110

If the auxiliary pump runs but produces no line pressure, the condition may be caused by a damaged Auxiliary Fluid Inlet Pump Seal (item 371) shown in the illustration above. Inspect this seal for being damaged or torn.

Part Number	Description
24268339	SEAL KIT, A/TRANS FLUID PUMP (AUX PUMP INLET)
