Service Bulletin

Bulletin No.: PI1178A

Subject: Engine Rough Run with Check Engine Light (CEL) On/Low Compression on Cylinder with Misfire, DTC P0300 Set

Models: 2013 Cadillac ATS
2013 Chevrolet Malibu
Equipped with 2.0L Turbo Engine (RPO LTG)

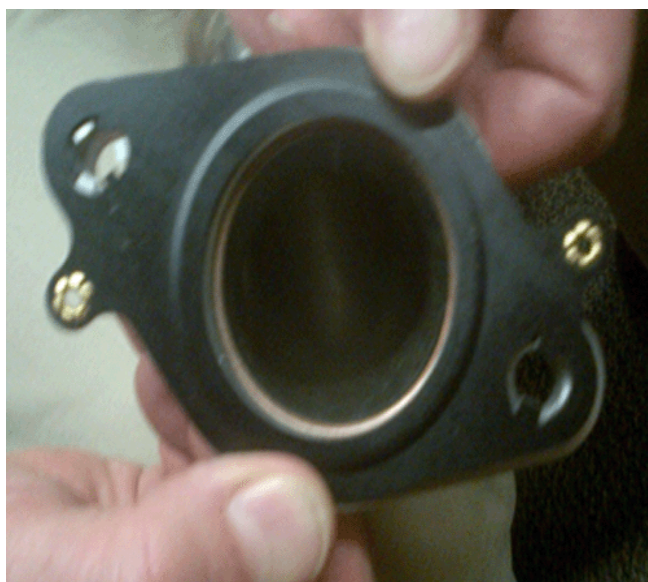
3657515

Note: When installing the turbo outlet gasket, make sure to position on the studs correctly as shown in the illustration above.

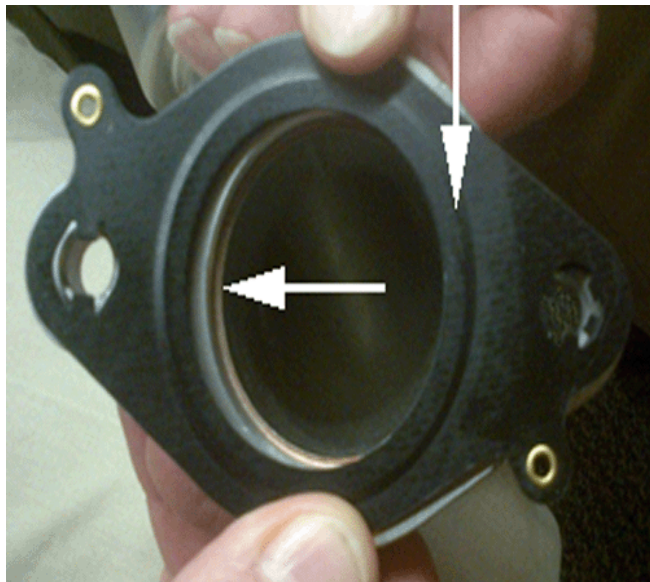
3657523

Note: If the gasket is flipped, as shown in the illustration above, it will reduce the outlet flow.
