Bulletin No.: PI1184

# Service Bulletin

**Subject:** Wrinkled Carpet Appearance Next to Door Sill Plate

**Models:** 2014 Cadillac ELR

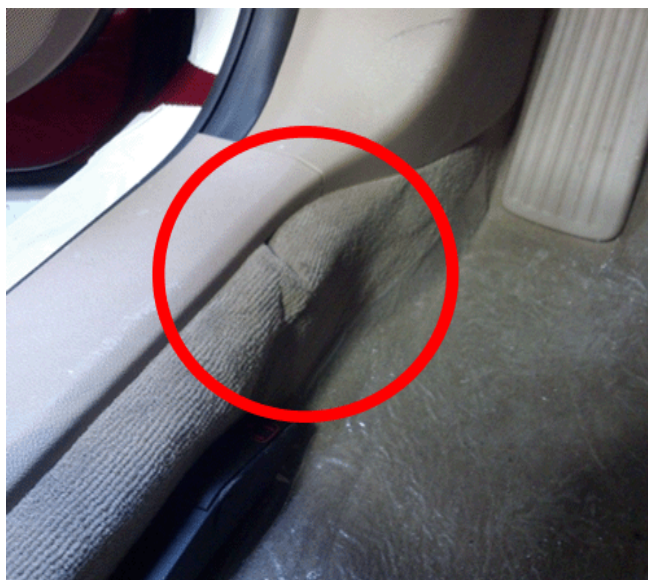
3735388

Some customers may comment that the carpet appears wrinkled next to the door sill plate.

This may be caused by the carpet insulation glued to the back of the carpet not drying smoothly, causing the carpet to appear wrinkled.

Remove the wrinkles from the carpet following the steps below:
