# Service Bulletin

Bulletin No.: PI1185

**Subject:** Sharp Metal Edge Across Top of Rear Compartment Opening (Rear Window Panel)

**Models:** 2013 Chevrolet Malibu (without eAssist )

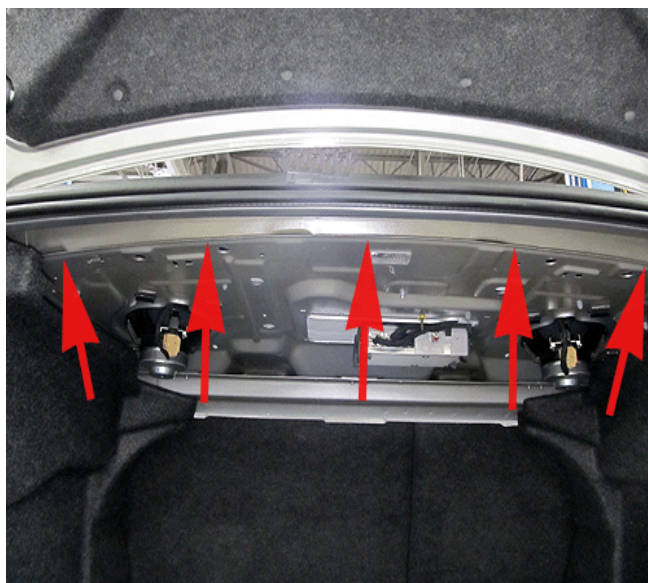
3746170

Some customers may comment that there is a sharp metal edge across the inside top area of the rear compartment opening.

During the manufacturing process, a metal burr may have been left on the rear edge of the rear window panel.
