48 14 05 October 13, 2014 2038621

Update Programming Electromechanical Steering Gear

Technical Bulletin

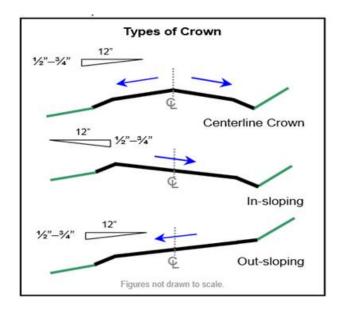
Be aware that vehicles tend to follow the natural crown of the road. Road crown can have a significant impact on the customer's perception of the pulling sensation while driving.

Depending on the vehicle owner's state of residence, the road crown direction and angle may vary.

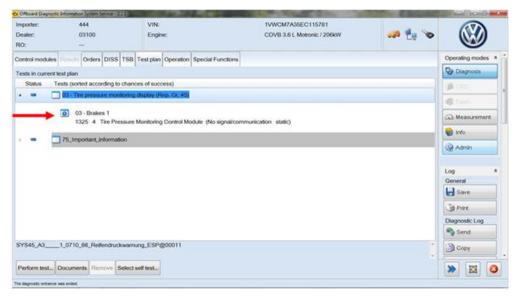
After performing the update a fault may be stored in address 03 (Brakes) for the Tire Pressure Monitoring Control Module. Clear that fault and then re-check to make sure no new DTCs are present.
