Technical Bulletin

87 14 05 June 19, 2014 2037095 Supersedes Technical Bulletin V871404 dated June 19, 2014 to revise production solution text for new coolant hose.

Air Conditioning Blows Warm, Compressor-Condenser Refrigerant Hose

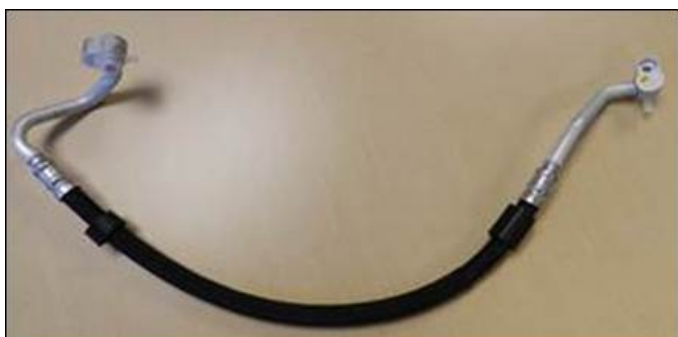
New refrigerant compressor/condenser hose 5N0 820 721H.

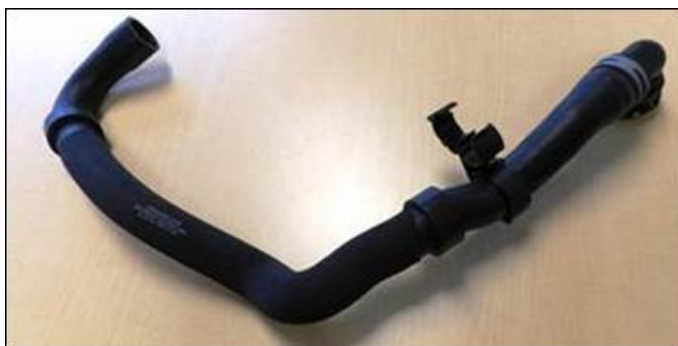
New coolant hose 5N0121051M with new double hose retainer.

New coolant hose comes with new retainer 5N0 121 093L.

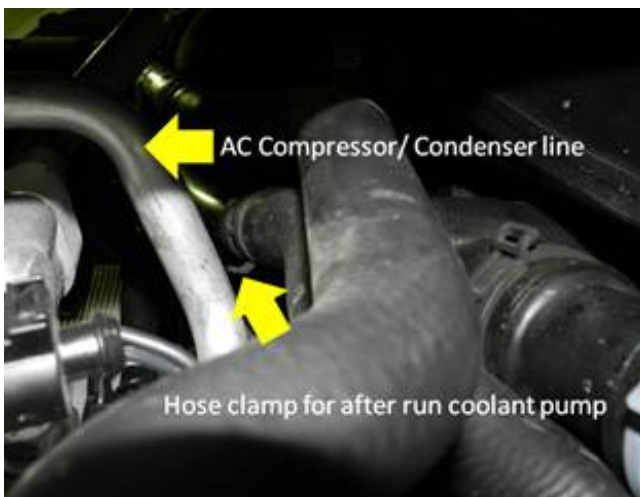
The picture shown in Figure 2 shows the refrigerant hose installed to capture the potential contact area.

- Locate the after run coolant pump and turn the clamp $\frac{1}{2}$ a turn from its original location away from the compressor/condenser hose.
