Technical Bulletin

87 14 06 June 19, 2014 **2037255**

Whistle Noise from Center Vent Area; Blower Set On 3 or 4 with Full Heat Selected

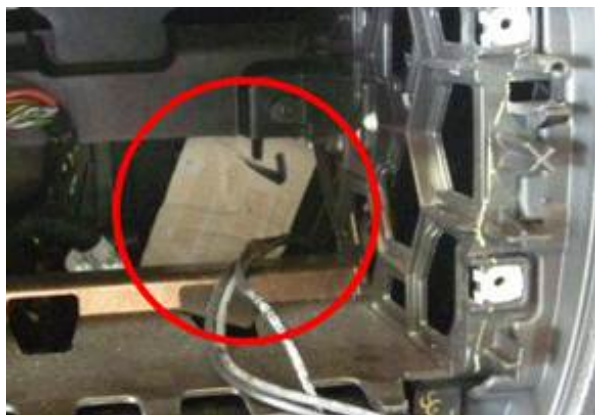
Figure 1

- Remove the radio, see Repair Group 91 in Elsa.
- The label on the air distribution unit is located on the front of the distribution unit assembly (Figure 1).
- Check the production date of the air distribution unit (Figure 2).

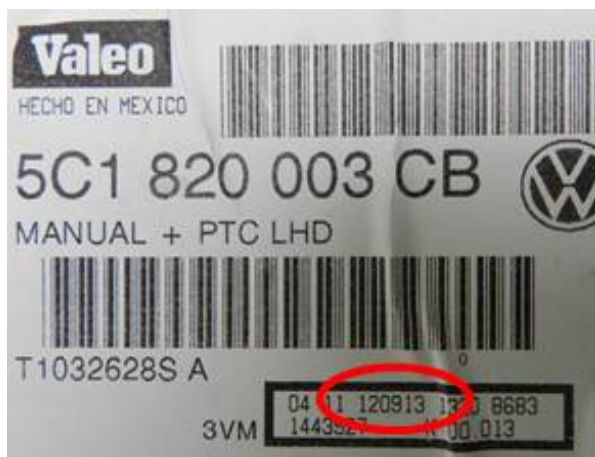
Figure 2

The production date is Day/Month/Year (120913 = Sep 12th 2013) (Figure 2).

All air distribution units built before 9/30/2013 will require both the left and the right temperature flap levers.

Air distribution boxes built between 10/01/2014 and March 20th 2014 will require only the right (Black) temperature flap lever.
