Bulletin No.: PIP5203

# Service Bulletin

**Subject:** Poor Engine Performance P0089 P228D P0171 Whine Noise From High Pressure Fuel Pump

**Models:** 2010-2011 Buick LaCrosse  
2011 Buick Regal  
2010 - 2011 Chevrolet Equinox  
2010-2011 GMC Terrain  
Equipped with 4 cylinder engine (RPO LAF)

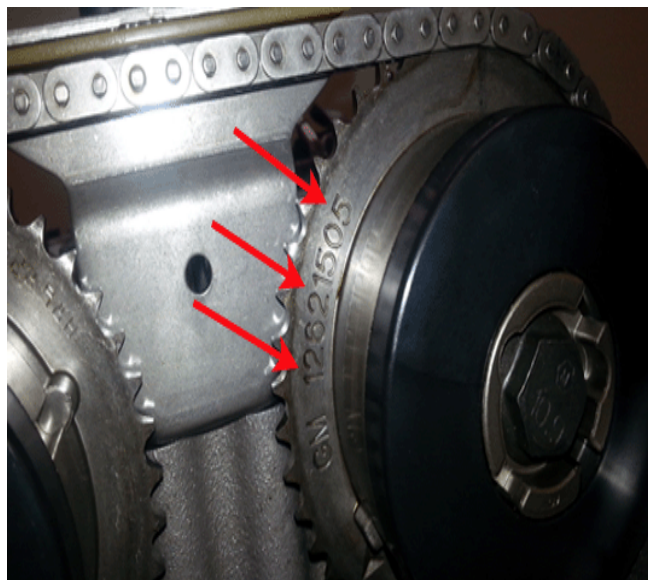
3872270

Below is an example of a 2011 intake camshaft actuator part number 12621505 and black in color (plastic cover piece).

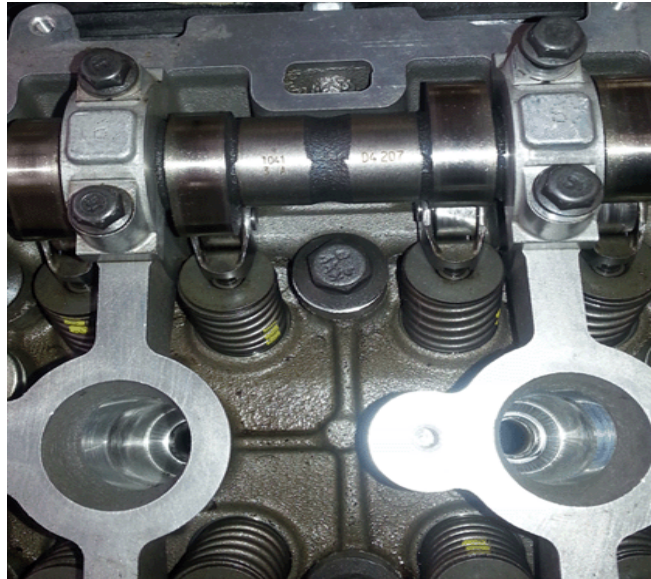
3872269

The camshafts can be identified by the last four digits of the part number located on a machined surface between the number 2 and number 3 cylinder camshaft lobes.

Below is an example of a 2011 intake camshaft part number 12634207.
