Service Bulletin

Bulletin No.: PIP5203A

Subject: Poor Engine Performance P0089 P228D P0171 Whine Noise From High Pressure Fuel Pump

Models: 2010-2011 Buick LaCrosse
2011 Buick Regal
2010 - 2011 Chevrolet Equinox
2010-2011 GMC Terrain
Equipped with 4 cyl engine (RPO LAF)

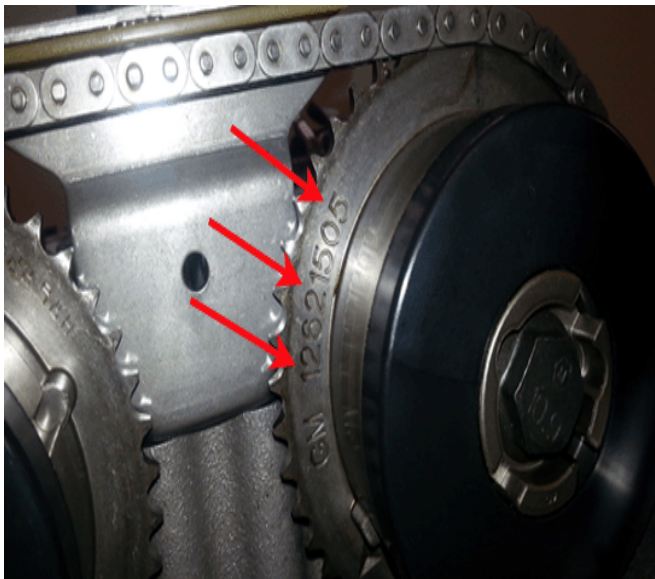
3872270

Below is an example of a 2011 intake camshaft actuator part number 12621505 and black in color (plastic cover piece).

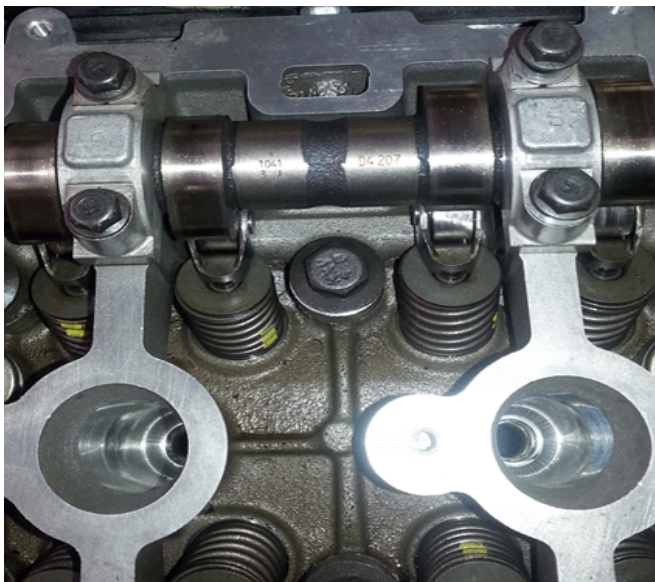
3872269

The camshafts can be identified by the last four digits of the part number located on a machined surface between the number 2 and number 3 cylinder camshaft lobes.

Below is an example of a 2011 intake camshaft part number 12634207.
