# Service Bulletin

Bulletin No.: PIP5210

**Subject:** Oil Leak At Front Of Engine

**Models:** 2010-2011 Buick Lucerne  
2010-2011 Chevrolet Impala  
Equipped with a 3.9L engine (RPO LGD)

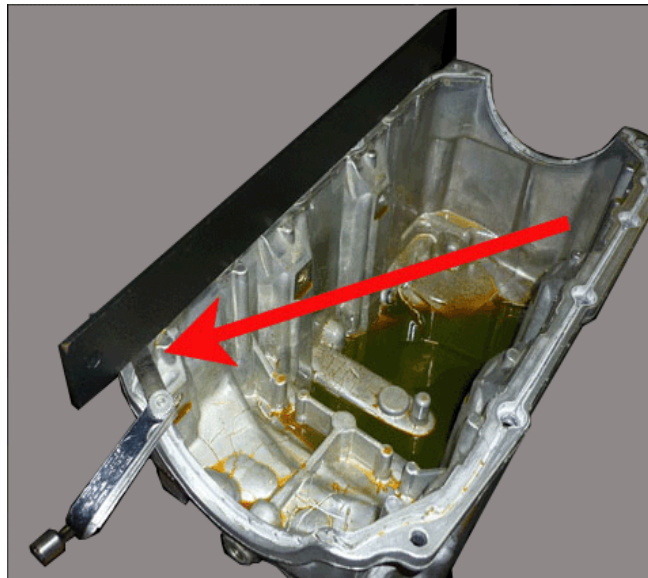
3957939

Some customers may comment on an oil leak from the front of the vehicle. Upon further inspection the leak can be isolated to the engine oil pan to front cover mating surface. This condition may be caused by warpage/taper of the oil pan sealing surface.

Using a straight edge and a feeler gauge measure taper on each side rail of the oil pan as shown below.

If the taper is greater than .005"(0.127mm) the oil pan sealing surfaces will require resurfacing/milling by a capable machine shop.

If taper is .005"(0.127mm) or less no machining will be required. Note: If taper is .005"(0.127mm) or less, apply a thin layer of sealer GM P/N 12346004 (Canadian P/N 10953480), or equivalent to the oil pan rail(s) the length of the tapered area to ensure that the gasket seals to the pan.
