Service Bulletin

Bulletin No.: PIP5211

Subject: SUV Rough Idle

Models: 2015 Cadillac Escalade models
2015 Chevrolet Tahoe, Suburban
2015 GMC Yukon models
With engines 5.3L, 6.2L, L83, L86

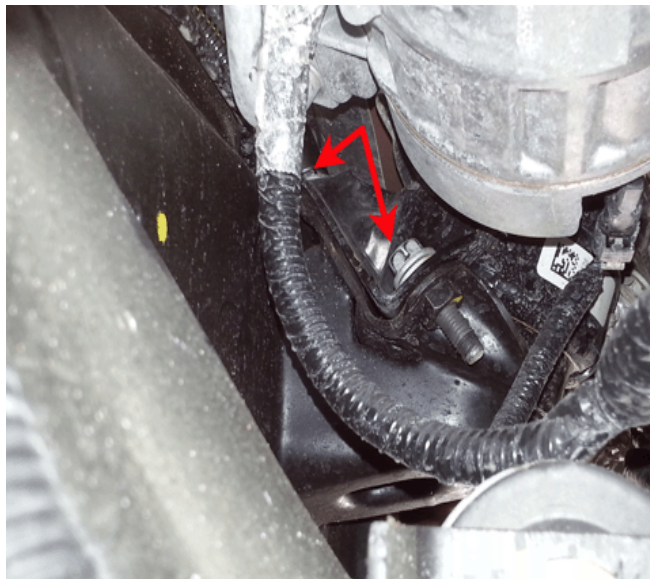
3955251

Loosen engine mount bolts at frame attachment points.
