Service Bulletin

Bulletin No.: PIP5212

Subject: Concern Of An Engine Thermostat Tick Noise And/Or Running Hot

Models: 2014 Chevrolet Corvette
2014-2015 Chevrolet Silverado 1500 Suburban, Tahoe
2014-2015 GMC Sierra 1500 Yukon
with engines 4.3L, 5.3L 6.2L RPO's LV3, L83, L86, LT1

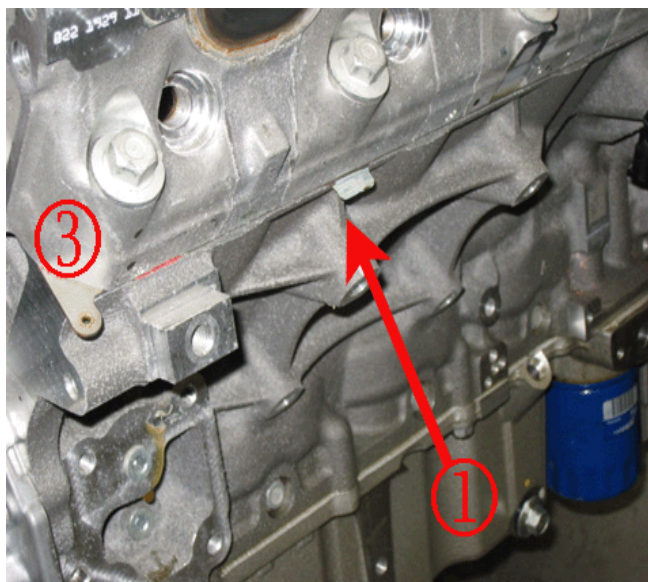
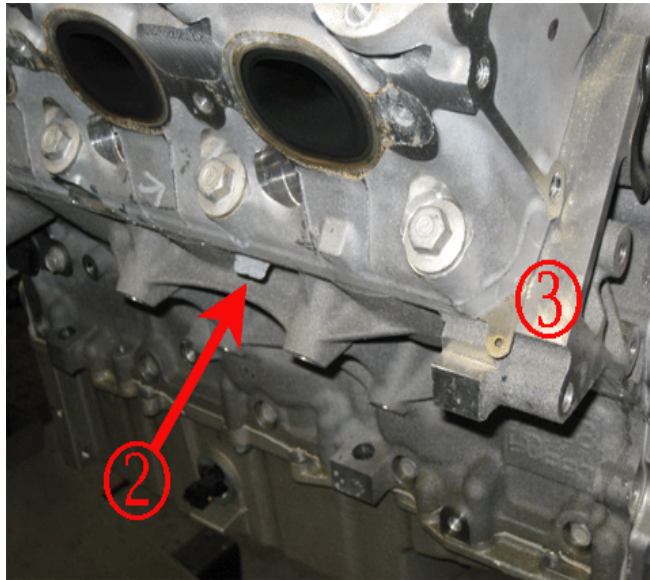
3960232

Per the attached pictures, the head gasket locating tabs for both of the engine cylinder banks should be toward the front of the engine.

1. Bank 1 tab near cylinder 3
2. Bank 2 tab near cylinder 4
3. Is the front of the engine

If the head gasket locating tabs are found to be closer to cylinders 5 or 6, this indicates the head gaskets were installed incorrectly restricting the engine coolant flow.

Replace the head gasket to repair for this concern.
