Service Bulletin

Bulletin No.: PIP5239

Subject: Commercially Available Tool For 1.2L LL0 Piston Installation

Models: 2013 - 2015 Chevrolet Spark
Equipped with 1.2L LL0

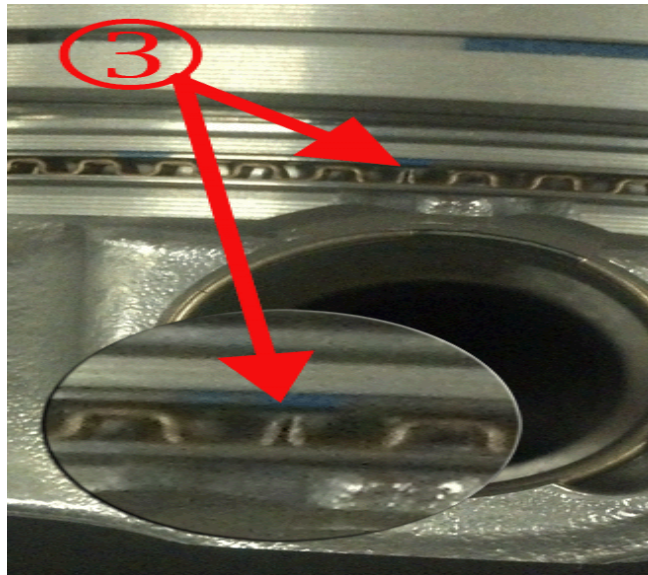
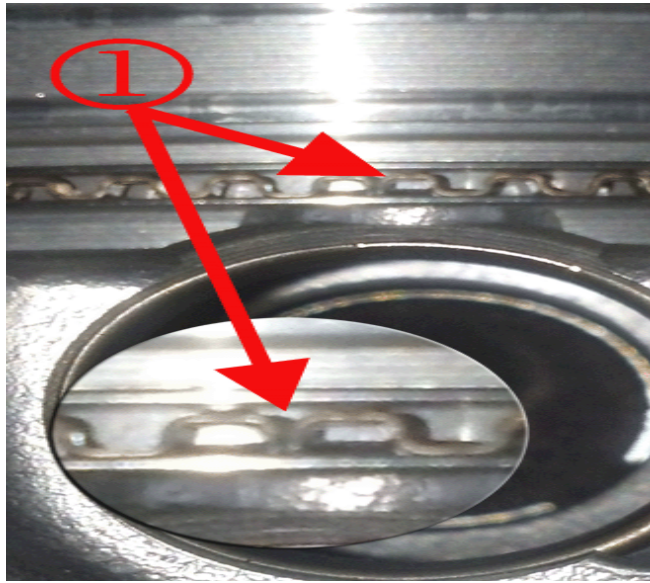
3999428

Examples of correct positioning of the oil control expander ring.

All piston rings including the oil expander ring must be properly positioned prior to clocking during installation or piston, piston ring or cylinder wall damage will result.

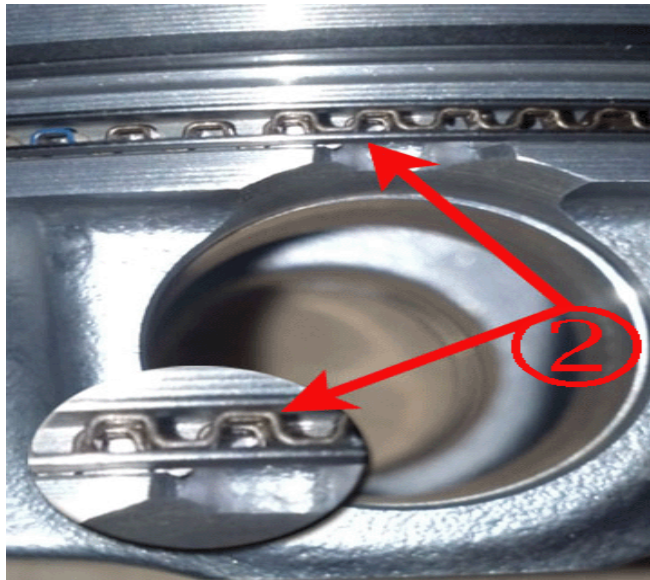
3999423

Example of improperly positioned oil control expander ring. (Overlapped).

The WISECO RCS07061 ring compressor sleeve is a cone style piston installer that will not allow the piston / ring assembly to pass if the piston rings are not properly positioned.

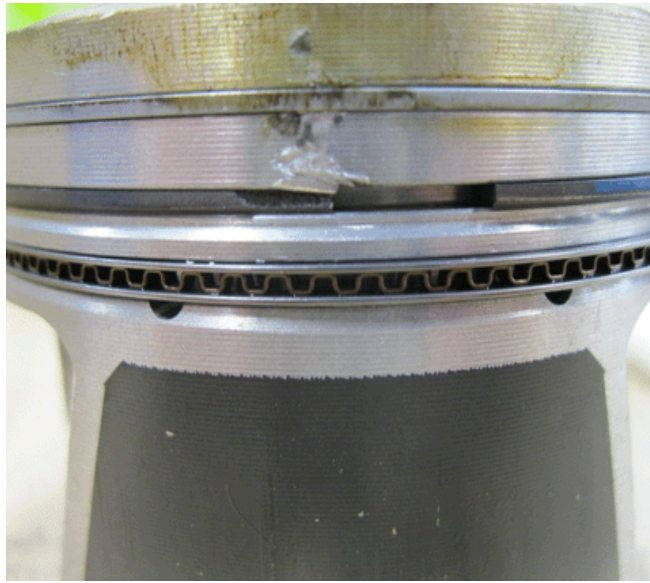
3999419

Example of improperly positioned 2nd compression ring with piston damage.
