Service Bulletin

Bulletin No.: PIP5246

Subject: (EREV) Reduced Propulsion with P0C17 P1B03 Or P0C01 (Drive Motor 1 Only)

Models: 2011- 2015 Chevrolet Volt
2014- 2015 Cadillac ELR

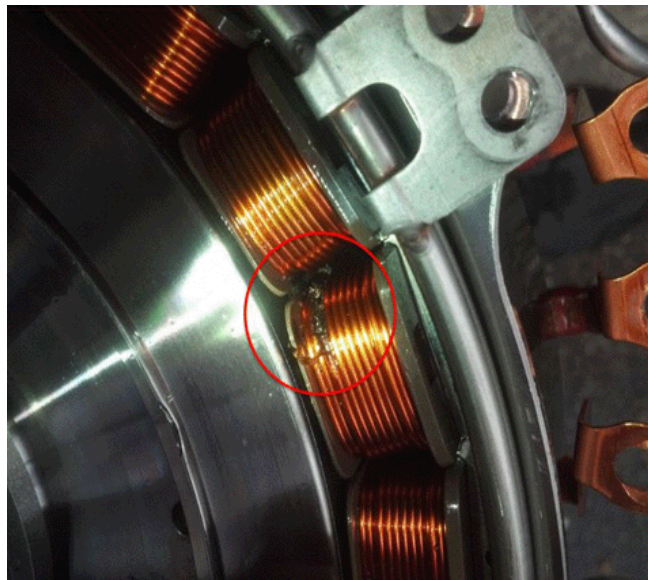
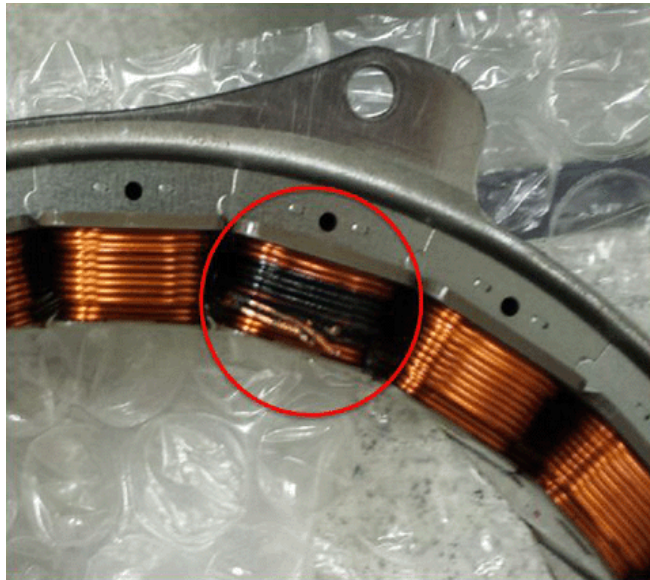
4040532

Some SI diagnostic procedures may not comprehend the possibility of the Motor 1 Stator as the cause of these DTCs. If one or more of these diagnostics are set, especially on a vehicle with a lifetime fuel economy below 50 mpg and above average annual mileage, inspect the Motor 1 Stator for damage as shown in the pictures below.

If no damage is found, replace all of the following parts: Motor 1 Position Sensor, Transmission Internal Harness, and Motor 1 Stator (damage may be on windings below the top layer). Replacing the Drive Motor Generator Control Module should only be ordered if the condition persists after replacing these parts.
