# Service Bulletin

Bulletin No.: PIT529

**Subject:** Wind Whistle Noise At Highway Speeds From Left Or Right Rear Quarter Glass Area

2015 Chevrolet Suburban, Tahoe

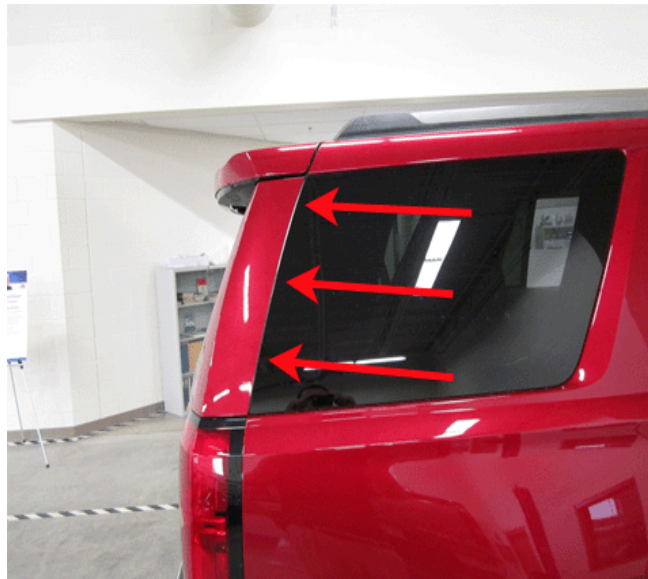
3827986

1. The fit between the exterior "D" pillar trim and the rear quarter glass in the area shown below.

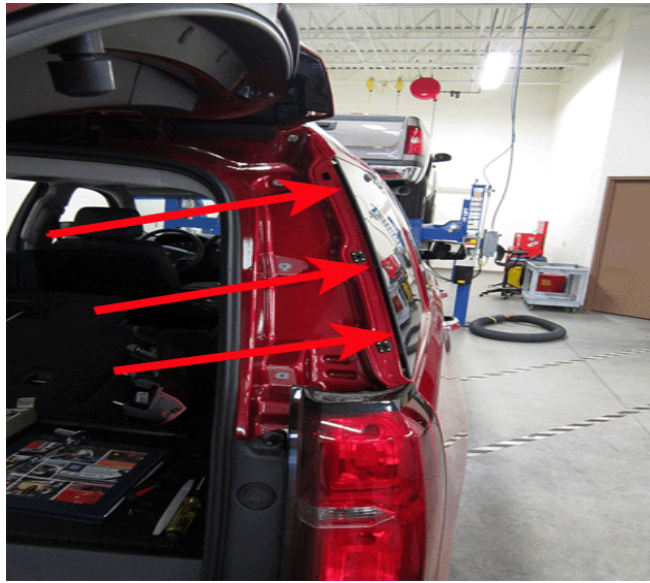
3827994

Excessive urethane from the quarter glass installation may not allow the exterior "D" pillar trim to fit properly against the rear quarter glass, as shown below.

1. Use a sharp knife and cut off the excessive urethane, as shown below. This will allow the exterior "D" pillar trim to fit correctly against the rear quarter glass.

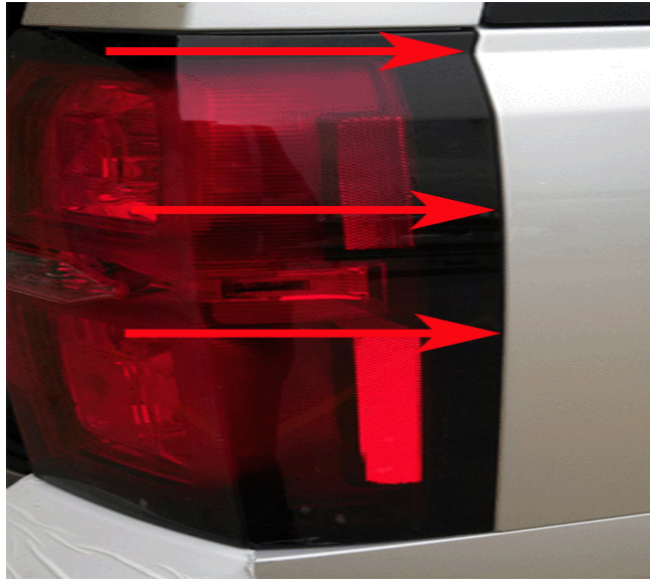
3901934

2. Between the rear tail light assembly and the quarter panel, as shown below

2. Install a 5mm X 5mm (3/16 X 3/16) piece of closed cell foam tape along the entire length of the tail light assembly, as shown below.
