Service Bulletin

Bulletin No.: PIT5259A

Subject: Installation Tip - Door Striker Cover Installation During PDI

Models: 2015 Cadillac Escalade Models
2015 Chevrolet Tahoe LTZ, Suburban LTZ
2015 GMC Yukon Denali Models

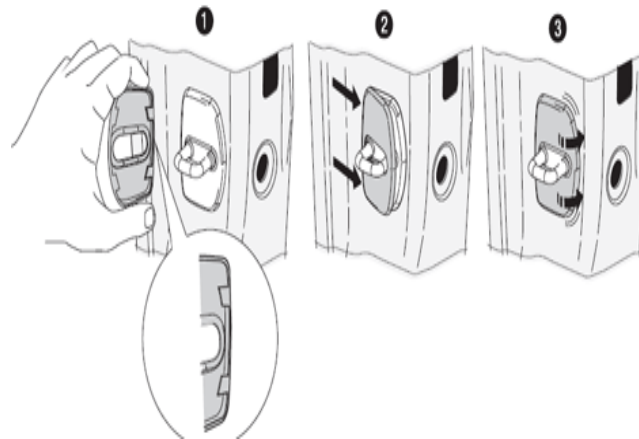
3723507

There have been reports of these covers being installed incorrectly / backwards.

Make sure the rounded side of the cover is positioned towards the outboard side of the vehicle, as reflected below:
