# Service Bulletin

Bulletin No.: PIT5267

**Subject:** Creak Or Pop Type Noise Coming From Windshield Area During Cold Ambient Temperatures

**Models:** 2012-2014 Buick Enclave  
2012-2014 Chevrolet Traverse  
2012-2014 GMC Acadia

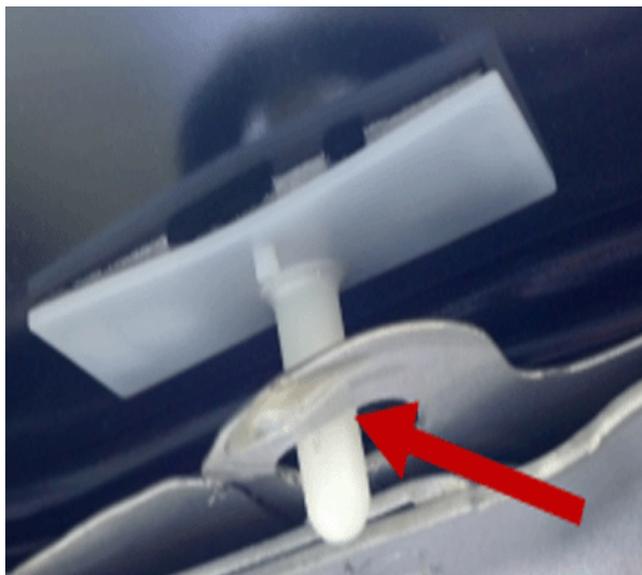
3766584

Some customers may comment on a creak, pop, tick, or itch type noise from the windshield area while driving. If the noise is coming from the upper windshield area, the condition may be caused by the windshield alignment pins in the upper corners of the glass, 5 inches in from the edge.

The windshield alignment pins are in the upper corners of the glass.

If the noise changes or is gone remove the windshield alignment pins.

If you cannot verify the concern, inspect the windshield alignment pins for rub/wear marks. If the pins shows rub/wear marks on them they will need to be removed.
