Service Bulletin

Bulletin No.: PIT5287

Subject: Diagnostic Tips - Front Shock Electrical Connector Terminal Removal

Models: 2015 Cadillac Escalade Models
2015 Chevrolet Suburban, Tahoe
2015 GMC Yukon Models
With Magnetic Ride Suspension Package (RPO Z95)

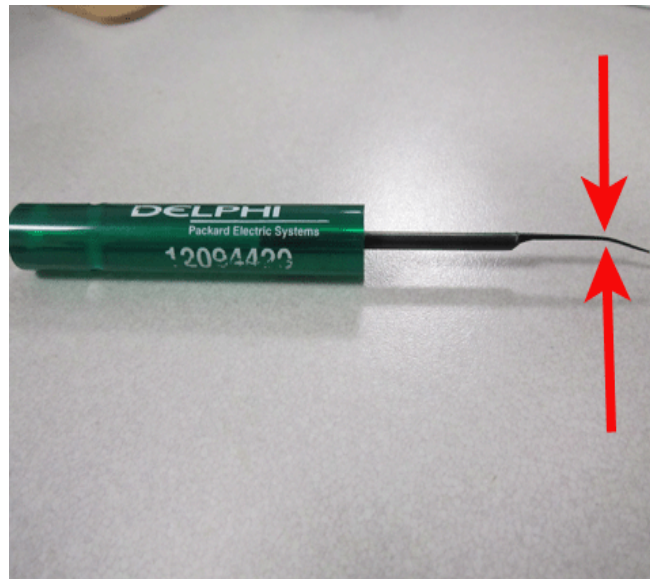
3824317

Certain repairs to the front suspension require the removal of the front shock electrical connector terminals. Because the terminals are positioned deep into the connector body, it may be difficult to remove the terminals.

The use of terminal release tool J-38125-12A (Delphi # 12094429) with a small modification has been found to make removal of the terminal(s) much easier.

Slightly bend the end of the J-38125-12A release tool, as shown in the photo below. While looking down into the connector body at the terminals, there is a purple TPA that will align itself in the release position when the release tool is inserted into the release hole. There is a metal locking tab on the terminal that will need to be pushed in before the terminal will pull out of the connector.
