Service Bulletin

Bulletin No.: PIT5287A

Subject: Diagnostic Tip - Front Shock Electrical Connector Terminal Removal

Models: 2015 Cadillac Escalade Models
2015 Chevrolet Suburban, Silverado, Tahoe
2015 GMC Sierra, Yukon Models
With Magnetic Ride Suspension Package (RPO Z95)

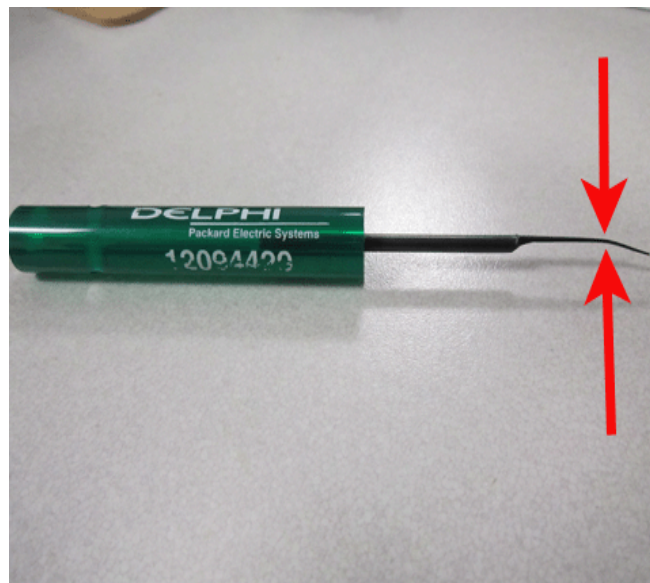
3824317

Certain repairs to the front suspension require the removal of the front shock electrical connector terminals. Because the terminals are positioned deep into the connector body, it may be difficult to remove the terminals.

Slightly bend the end of the J-38125-12A release tool, as shown in the photo below. While looking down into the connector body at the terminals, there is a purple TPA that will align itself in the release position when the release tool is inserted into the release hole. There is a metal locking tab on the terminal that will need to be pushed in before the terminal will pull out of the connector.
