# Service Bulletin

Bulletin No.: PIT5291

**Subject:** Wind Whistle Noise At Highway Speeds From Left Or Right Rear Quarter Glass Area

2015 Chevrolet Suburban, Tahoe

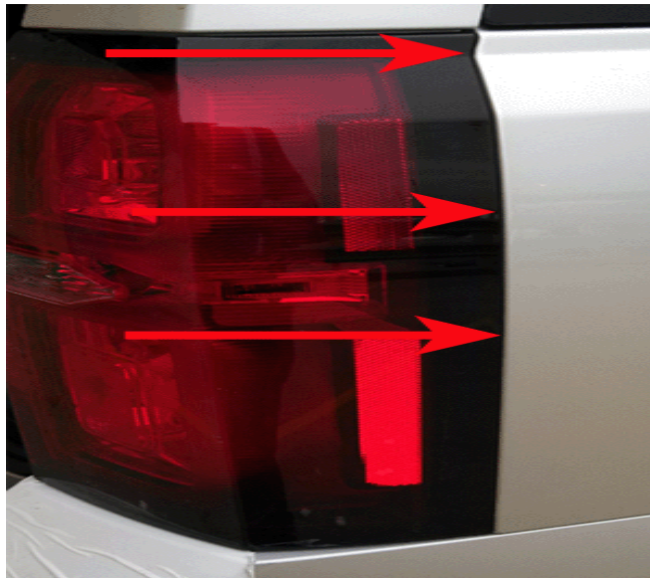
3901934

2. Between the rear tail light assembly and the quarter panel, as shown below

2. Install a 5mm X 5mm (3/16 X 3/16) piece of closed cell foam tape along the entire length of the tail light assembly, as shown below.
