Service Bulletin

Bulletin No.: PIT5294

Subject: Tiny Rattle And/Or Buzz Noise From Rear Of Vehicle (Inspect Exhaust Heat Shield)

Models: 2015 Cadillac Escalade Models
2015 Chevrolet Suburban, Tahoe
2015 GMC Yukon Models

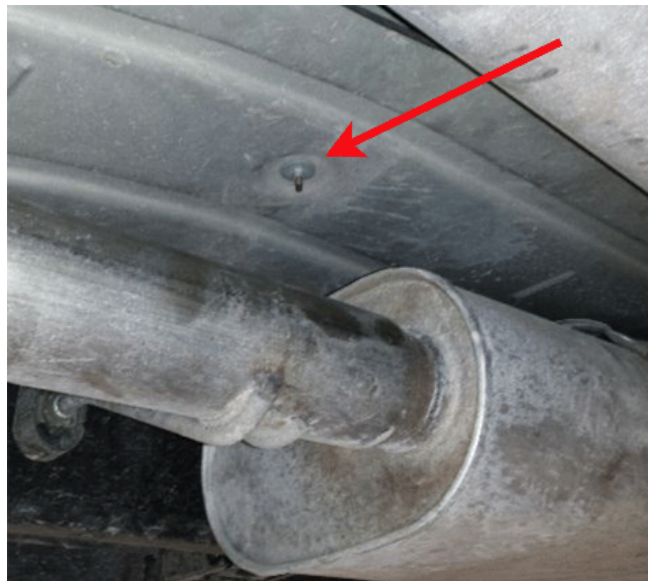
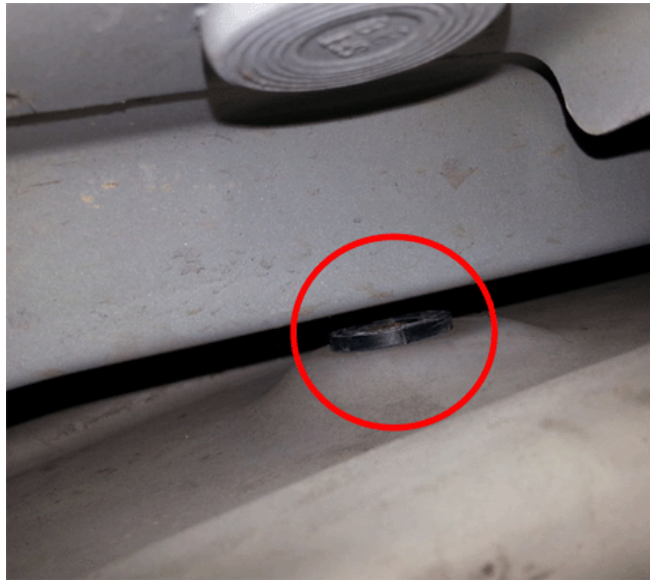
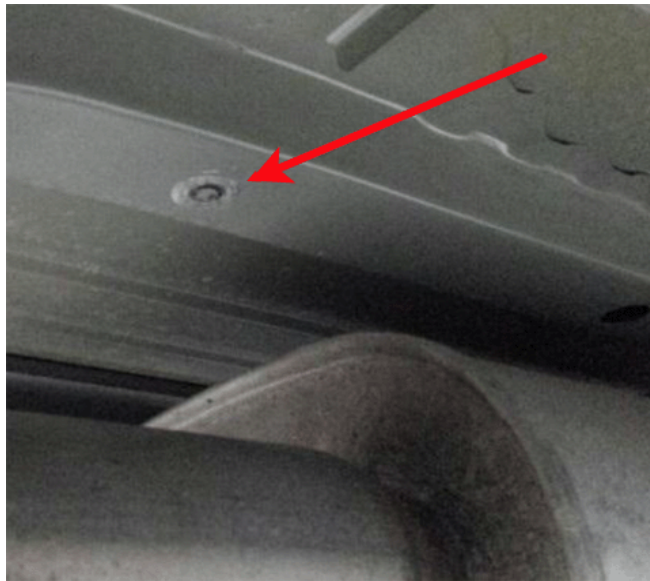
Some customers may comment of a tinny, rattle or buzz noise from the rear of the vehicle. There have been reports of this noise sounding like it is coming from the roof area, headliner, luggage rack, 2nd row seat, 3rd row seat, and/or a buzz type wind noise at higher speeds.

These concerns could be caused by the exhaust muffler heat shield mounting stud coming loose from the body, causing it to make noise, as shown below.

To correct this concern, replace the broken stud by installing a M6 rivet stud using the latest version of bulletin 10-08-45-001. Note: Be sure to use a drill stop when drilling the hole for the M6 rivet stud.
