# Service Bulletin

Bulletin No.: PIT5295

**Subject:** Unable To Install A CD Or DVD (Slot Misalignment)

**Models:** 2015 Chevrolet Suburban, Tahoe  
2015 GMC Yukon Models

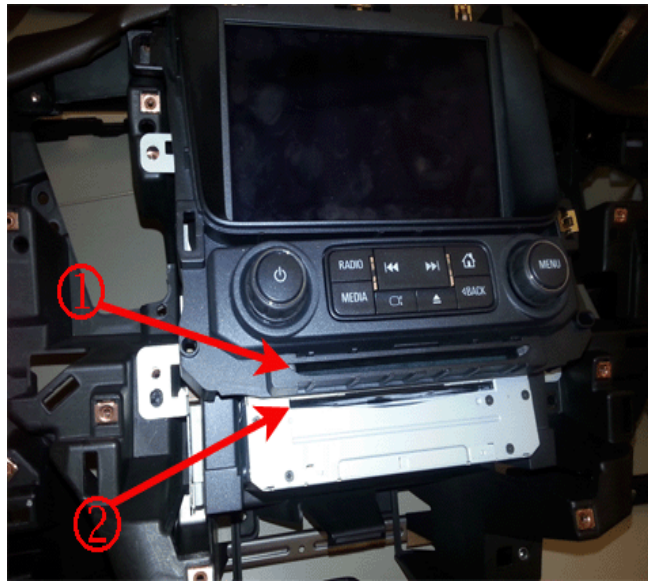
3921692

Some owners may comment that they are unable to install a CD or DVD in the player. This concern could be caused by the Integrated Center Stack or ICS (1) not being properly installed, causing a misalignment with the slot in the multimedia player (2), as shown below.

To correct this concern, remove the ICS and multimedia player. Reinstall the multimedia player ensuring the rear locating pin and front two common locating pins are properly engaged. Next, reinstall the ICS ensuring its rear locating pin and front two common locating pins (3) are properly engaged

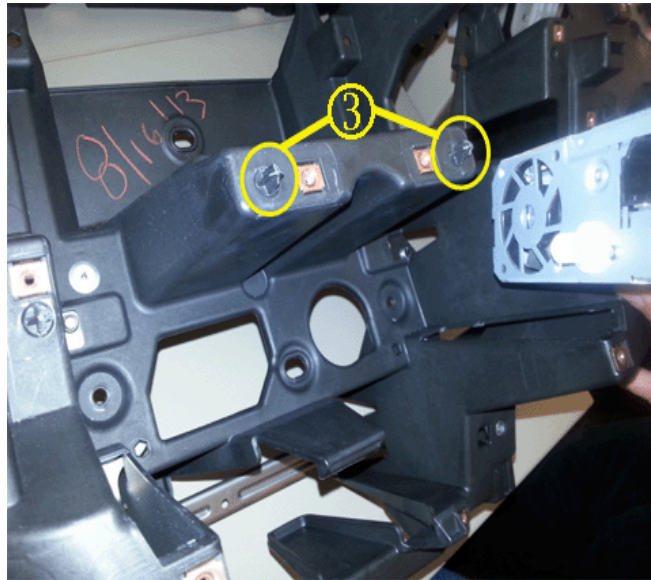
3921696

The ICS and multimedia player use two common locating pins (3), as shown below. When the ICS is installed, the two common locating pins (3) may not properly engage into the holes in the back of the ICS, causing the condition.
