Service Bulletin

Bulletin No.: PI1188

Subject: Duramax® Fuel Temperature Sensor Contacts Fuel Return Pipe After Pump Replacement

Models: 2012-2014 Chevrolet Silverado 2500/3500
2012-2014 GMC Sierra 2500/3500
Equipped with 6.6L Diesel Engine (RPO LML)

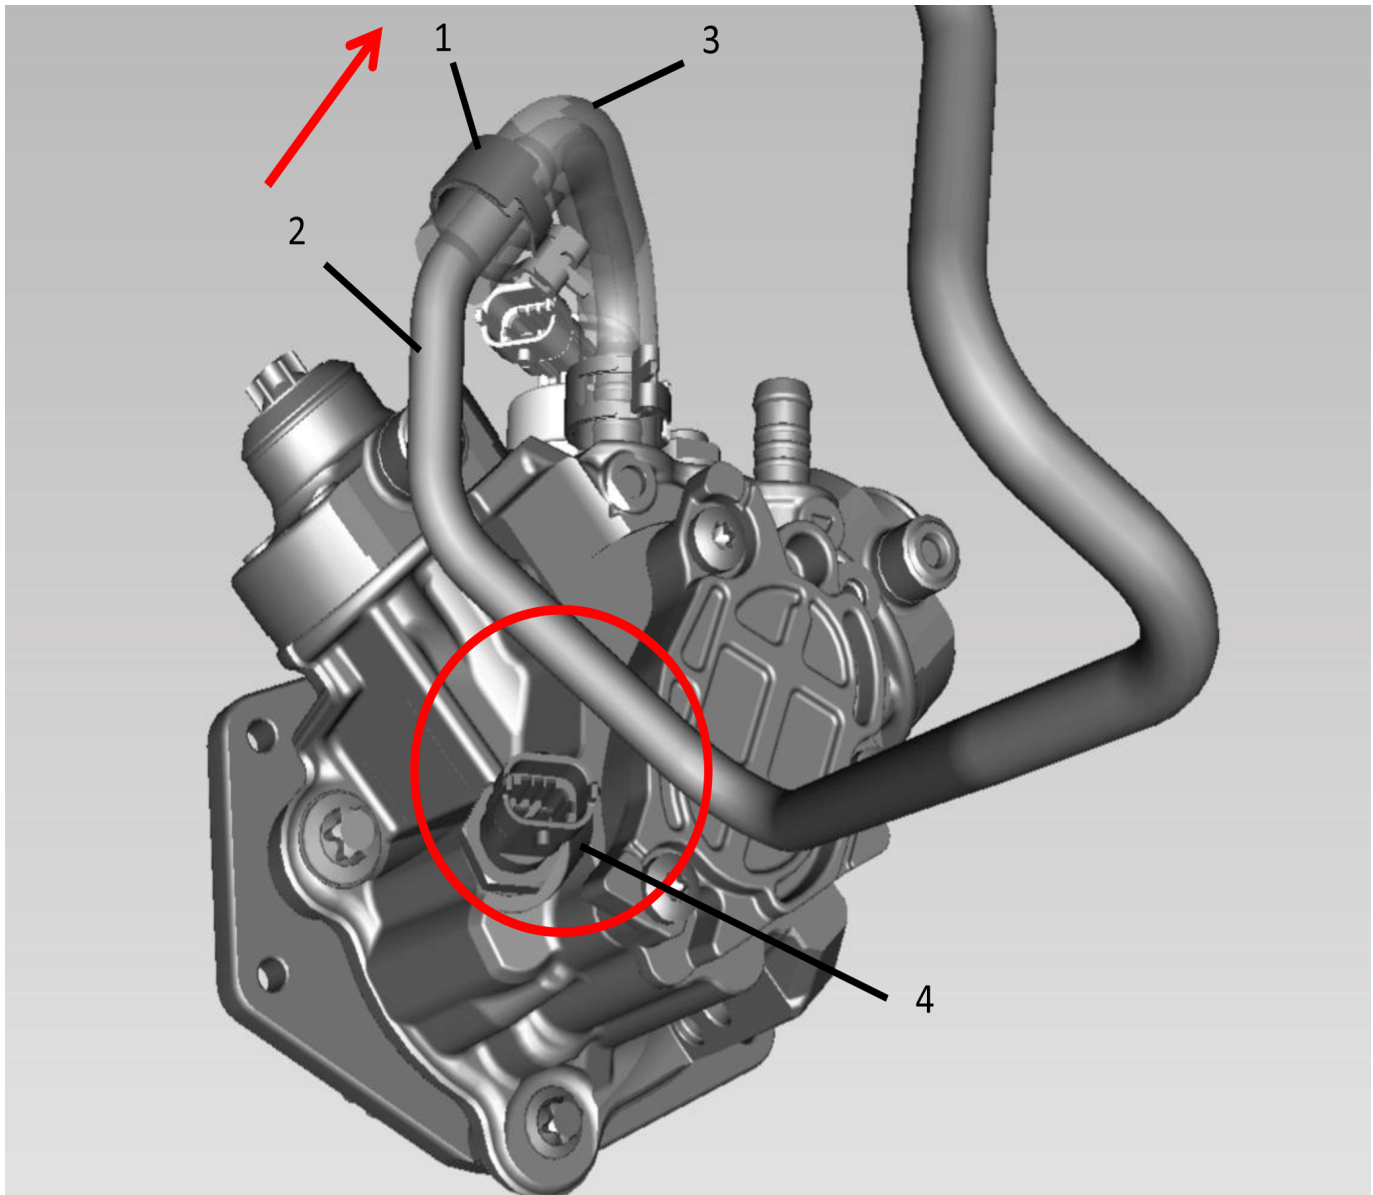
3629232

The following information may be helpful for a technician when replacing a fuel pump. If there is contact between the fuel temperature sensor connector and the fuel return line or clearance is very tight, please follow this service recommendation.

Follow the procedure below for inspecting the fuel return pipe to see if adjustment is needed. If sufficient clearance of 5 mm cannot be obtained through adjustment, replace the fuel return pipe with the newer design.

1. Remove the fuel return pipe to fuel return hose clamp (1).
2. Adjust the fuel return pipe (2) deeper into the fuel return hose (3).
3. Rotate the pipe assembly away from the fuel temperature sensor (4).
4. Install the fuel return hose clamp (1).
