Service Bulletin

Bulletin No.: PI1202

Subject: Intermittent Radio Shut Off, Instrument Cluster Gauges Inoperative, Blind Spot Indicator Flashing, Multiple Communication Codes Set

Models: 2013-2014 Buick Enclave
2013-2014 Chevrolet Traverse
2013-2014 GMC Acadia

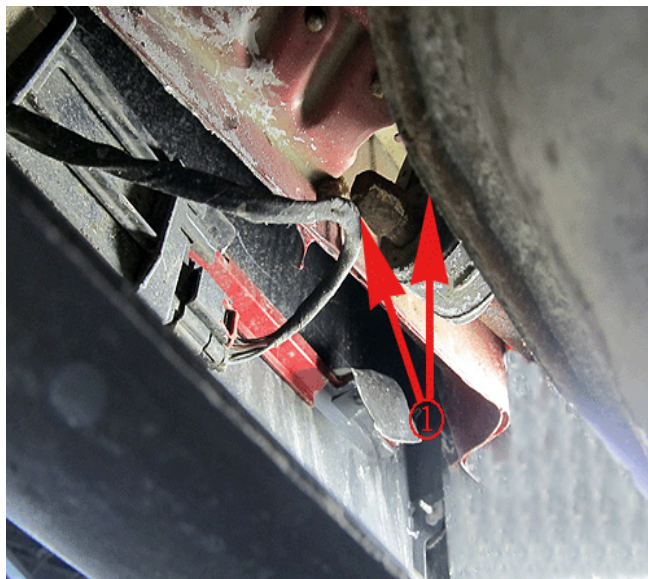
3766031

This condition may be caused by the side object detection sensor wiring harness, located in the rear of the vehicle, making contact with the exhaust system. This contact may wear through the wiring insulation, affecting the LAN communications.

1. Locate the side object detection sensor wiring harness on the right rear of the vehicle between the exhaust muffler and the rear compartment floor lower extension.

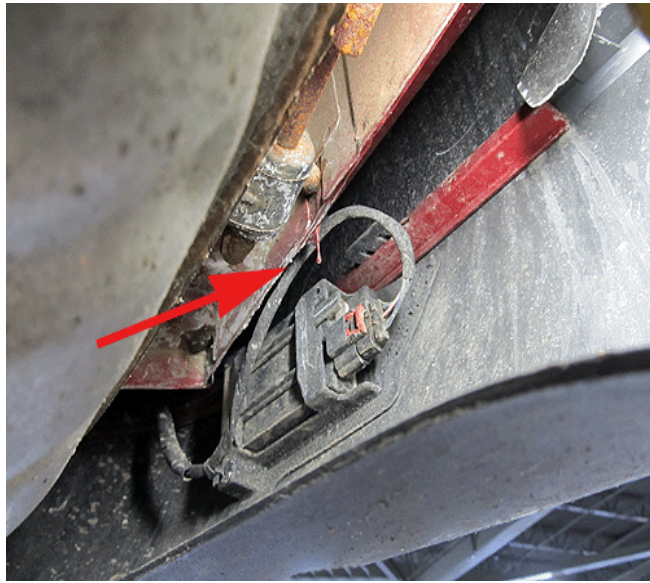
3766032

2. Inspect the wiring harness for a contact condition with the muffler or exhaust mounting (1). Check for worn through wiring insulation, burned wire insulation or broken wires.
3. Repair any wiring as required. Refer to GMLAN and Media Oriented Systems Transport (MOST) Wiring Repairs in SI for specific repair procedures.
4. Reposition the wiring harness to prevent contact with exhaust components.

Position the harness outboard of the rear compartment floor lower extension as shown. It may be necessary to loop the wiring over itself and secure with a wire tie to take up any excess slack in the wiring.
