Service Bulletin

Bulletin No.: PI1209

Subject: Poor Keyless Entry Transmitter Range

Models: 2013-2015 Buick Encore
Equipped with Premium Package (RPO 1SN)

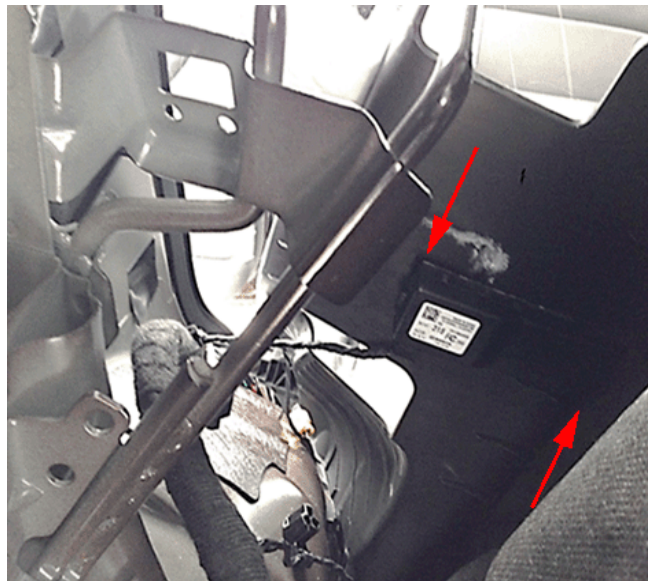
3787937

Some customers may comment on a poor keyless entry transmitter range of less than 15 m (50 ft). This may be due to the location of the remote control door lock receiver.

Relocate the remote control door lock receiver from the rear quarter panel to the adjoining trim following the procedure listed below.

1. Remove the LH quarter lower rear trim panel. Refer to Quarter Lower Rear Trim Panel Replacement in SI.
2. Release the receiver from tabs on bracket.
3. Using hook and loop velcro such as Kent Industries Part# KT14369 or equivalent, cut a piece the length of the receiver and apply on the bottom side.

4. Remove the velcro and install the receiver in its new location as shown in the illustration above.
