Service Bulletin

Bulletin No.: P11212A

Subject: Improper and Incomplete Instrument Cluster Programming

Models: 2014 Buick LaCrosse, Regal
2014 Cadillac ATS, CTS Sedan (VIN A), ELR, SRX, XTS
2014 Chevrolet Impala, Silverado 1500
2015 Chevrolet Silverado, Suburban, Tahoe
2014 GMC Sierra 1500
2015 GMC Sierra, Yukon

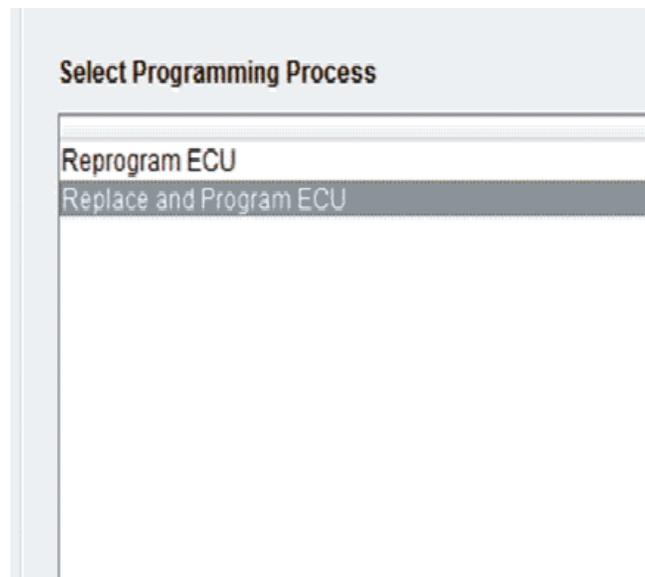
3951979

1. DO NOT turn the ignition OFF. Ensure that all IPC, DLC and programming tool connections are secure and the TIS terminal operating software is up to date.
2. Select Programming Process "Replace and Program ECU" for the IPC in TIS2WEB.
3. If the IPC can still not be programmed, turn the ignition OFF, disconnect the battery, and wait for at least two minutes.

4. Connect the battery, turn the ignition ON and attempt "Replace and Program ECU" for the IPC again in TIS2WEB. The IPC should program.
