Service Bulletin

Bulletin No.: P11219

Subject: Turbocharger Cracks in Inlet Port Center Web Area

Models: 2014-2015 Buick Regal
2013-2015 Cadillac ATS
2014-2015 Cadillac CTS (VIN A)
2013-2015 Chevrolet Malibu
Equipped with Turbocharged 2.0L Engine — RPO LTG

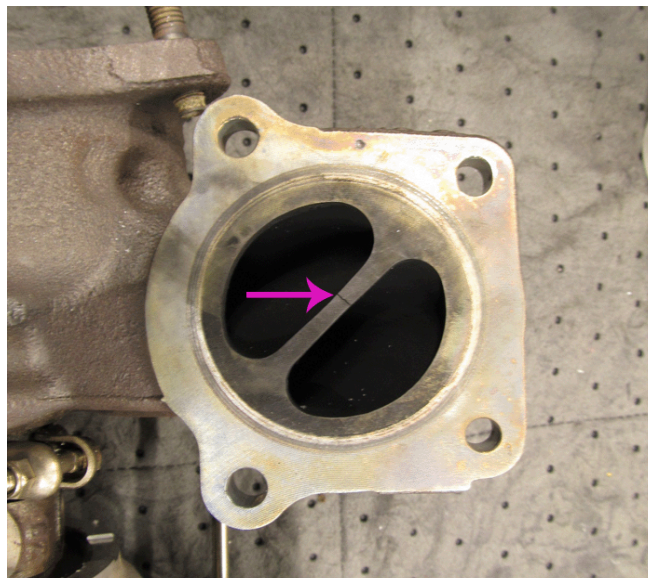
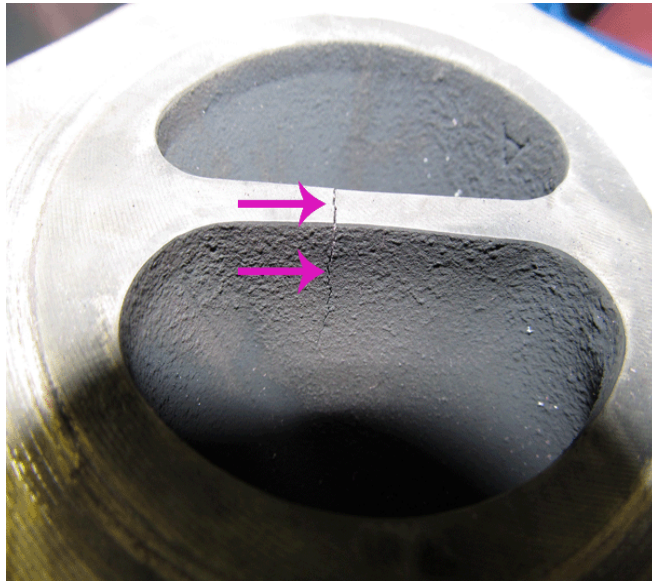
3804909

Turbocharger Cracks That Do Not Require TC Replacement

Review the following graphics for views of TC cracks that **DO NOT** require TC replacement:

The appearance of cracks in the center section of the turbocharger **DO NOT** affect the performance of the TC. The TC should not be replaced for cracks in this section.
