Service Bulletin

Bulletin No.: P11220

Subject: Front Edge of Door Contacting Rear Edge of Fender While Opening Door

Models: 2014 Chevrolet Corvette
Condition/Concern

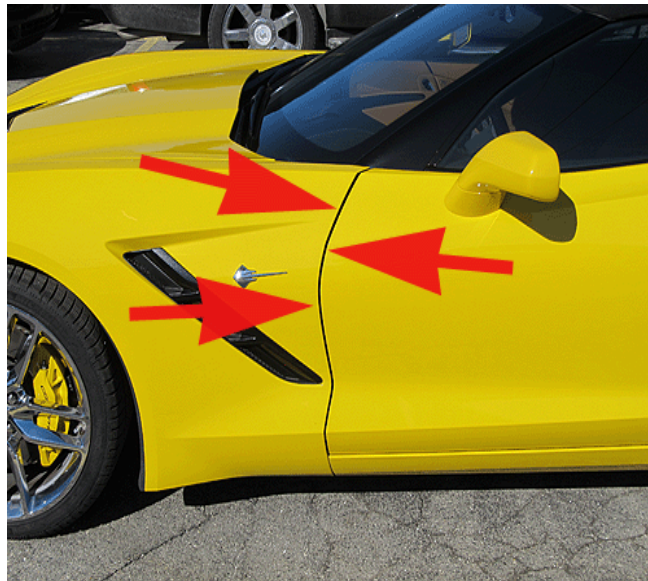
3804281

Some customers may comment that the front edge of the front door is contacting the rear edge of the front fender when opening the door. This condition may be present on both the left and right front doors.

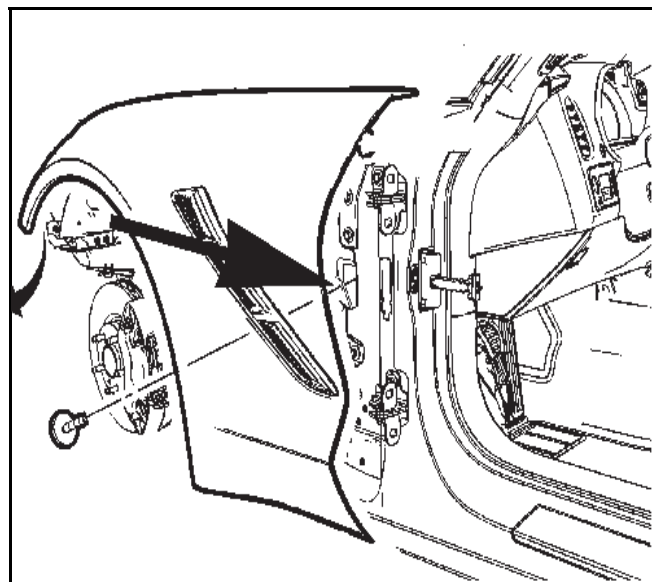
3804296

This condition may be caused by the fender attachment at the rear center location.
