# Service Bulletin

Bulletin No.: PI1236

**Subject:** Right (Passenger Side) Windshield Wiper Arm Has No Tension on Wiper Blade

**Models:** 2014 Cadillac ELR

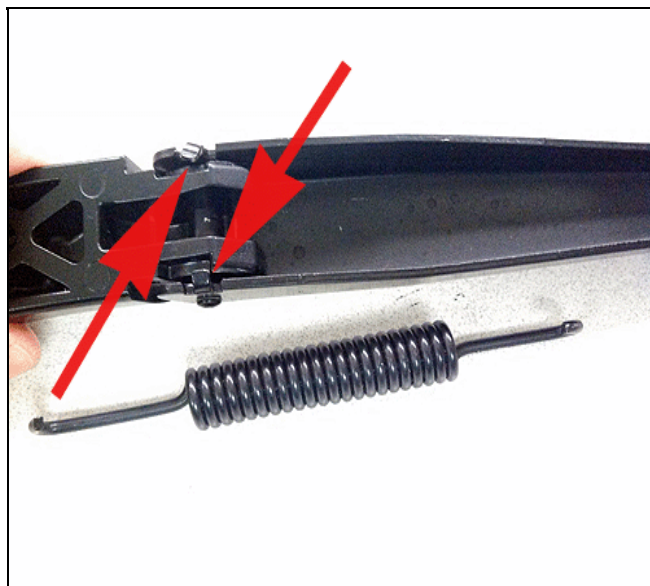
3821063

Some dealerships or customers may comment that the right (passenger side) windshield wiper arm has no tension on the wiper blade.

The right (passenger side) wiper arm does not have a 90 degree service position and can only be pulled up several inches from the windshield. If the customer or dealership personnel pulls the wiper arm past the stops to the 90 degree position, both arm stops will bend out of place and the wiper blade tension spring will fall out. The left (driver side) windshield wiper arm is the only wiper arm that can be moved to a 90 degree service mode.

If the windshield wiper arm is damaged, replace the windshield wiper arm. Please do not submit a warranty claim as this type of damage is a dealership or customer pay repair.
