Service Bulletin

Bulletin No.: PI1248

Subject: Haptic Seat Motor Inoperative or Does Not Vibrate

Models: 2014 Cadillac CTS Sedan (VIN A)
Equipped with Sales Package RPOs Y65, Y66
Vehicles Built Prior to April 14, 2014

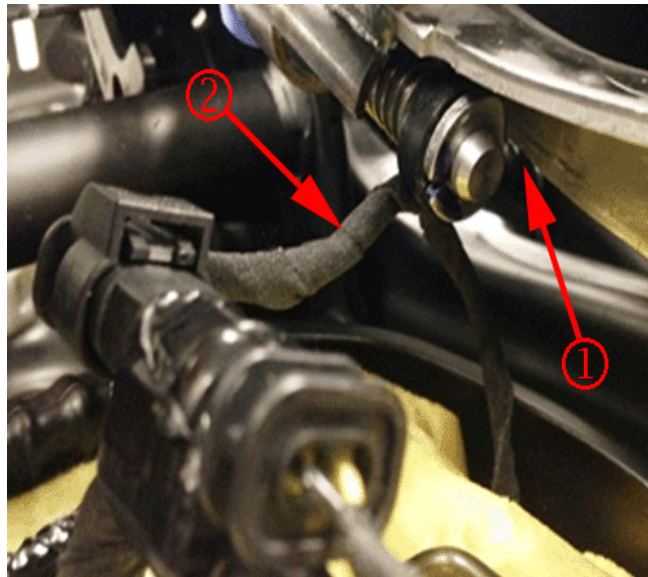
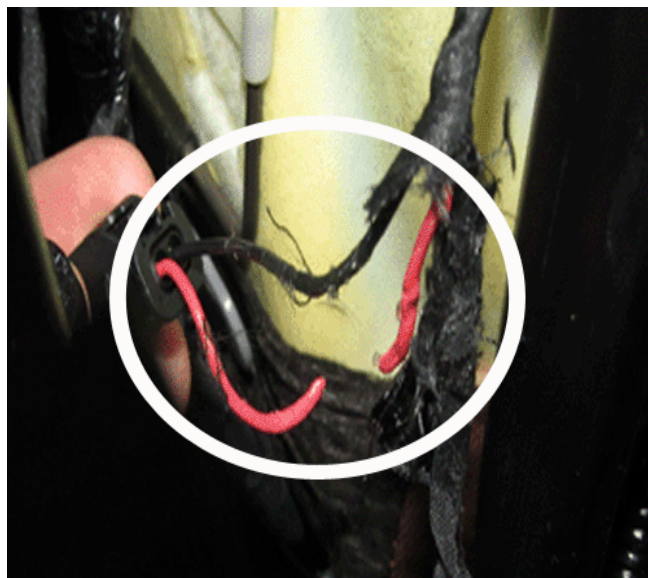
This condition may be caused when the lead screw on the up/down motor (1) comes in contact with the haptic pigtail (2) and cuts through the pigtail wire as shown in the illustrations above.

Repair the haptic pigtail wire following the procedure listed below:

1. Remove the driver seat. Refer to Driver and Passenger Seat Removal and Installation.
2. Perform the wire repair as needed. Refer to Wiring Repairs is SI.
