Service Bulletin

Bulletin No.: PI1249

Subject: Buzz/Rattle Noise from Rear Speaker Area

Models: 2011-2014 Chevrolet Camaro Convertible
Equipped with Premium Audio System (RPO UQA)

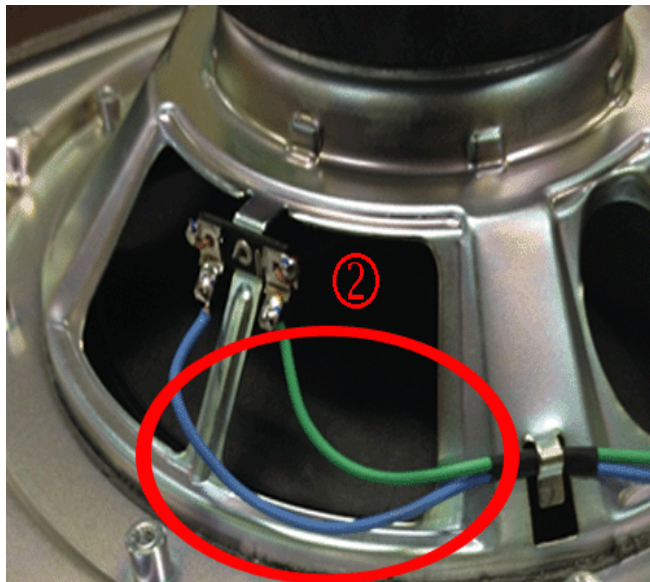
3905447

Some customers may comment on a buzz or rattle type noise coming from the rear speaker area. This may be caused by the sub woofer wiring coming in contact with the sub woofer cone.

9. Inspect the sub woofer wiring and verify the wiring is not in contact with the sub woofer cone paper (1). Adjust the blue wiring if needed and ensure the wire is resting outside the metal frame (2).
10. Install the sub woofer and nuts to the vehicle.
11. Install the seat back cushion.
12. Install the center trim panel.
13. Install the left and right seat belt trim panels.
14. Lower the convertible top.

Technicians should inspect and adjust the sub woofer wiring. Make sure the blue wire is resting on the metal frame and not on the cone paper.
