# Service Bulletin

Bulletin No.: PI1256

**Subject:** Engine Oil Leak Between Engine and Transmission

**Models:** 2014 Buick Regal  
Equipped with 2.0L Engine (RPO LTG)

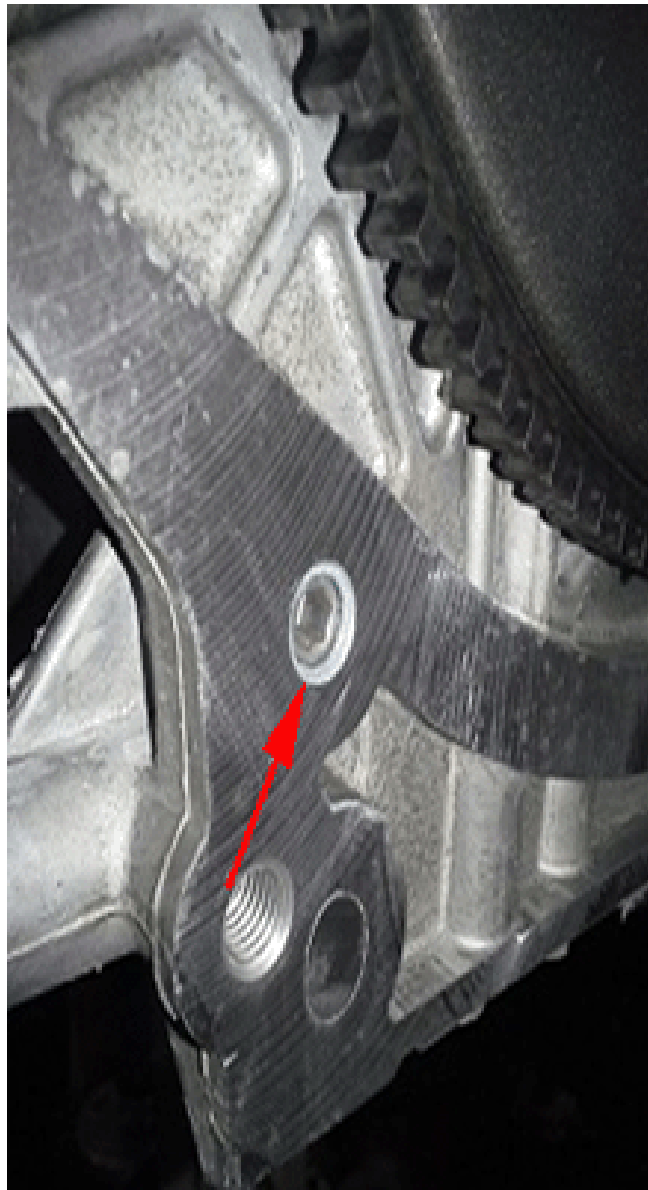
3708031

Some customers may comment on a fluid leak under the front end of the vehicle. Further inspection will reveal the leak to be engine oil and will show the leak is between the engine and transmission.

This condition may be caused by porosity in a drilled hole in the oil pan that is used for manual transmission vehicles, as shown in the illustration above.
