TECHNICAL BULLETIN
LTB00596NAS2
04 FEB 2014

SECTION: 412-00

Climate Control System Drain Tube Incorrectly Located

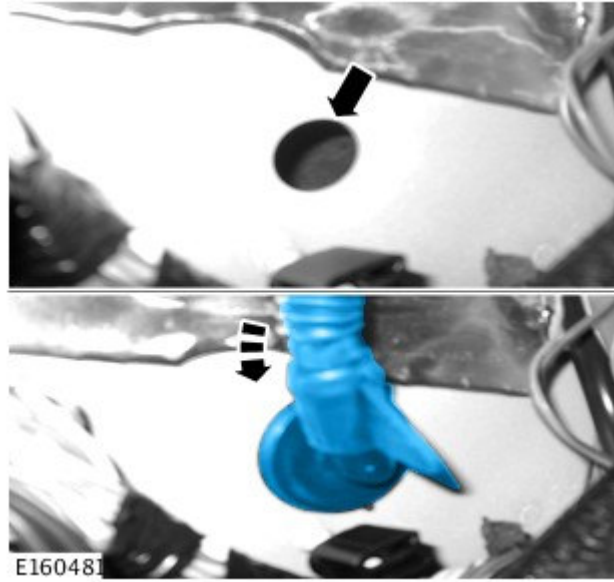
Cause: This may be caused by the Climate Control system drain tube being incorrectly located in footwell.

3. Check to see if the Climate Control system drain tube is connected correctly.
