TECHNICAL BULLETIN  
LTB00618NAS2  
28 APR 2014

**'Click' / 'Rattle' Noise From Engine Compartment When Driving**

**Range Rover Sport (LW)**

**Range Rover (LG)**

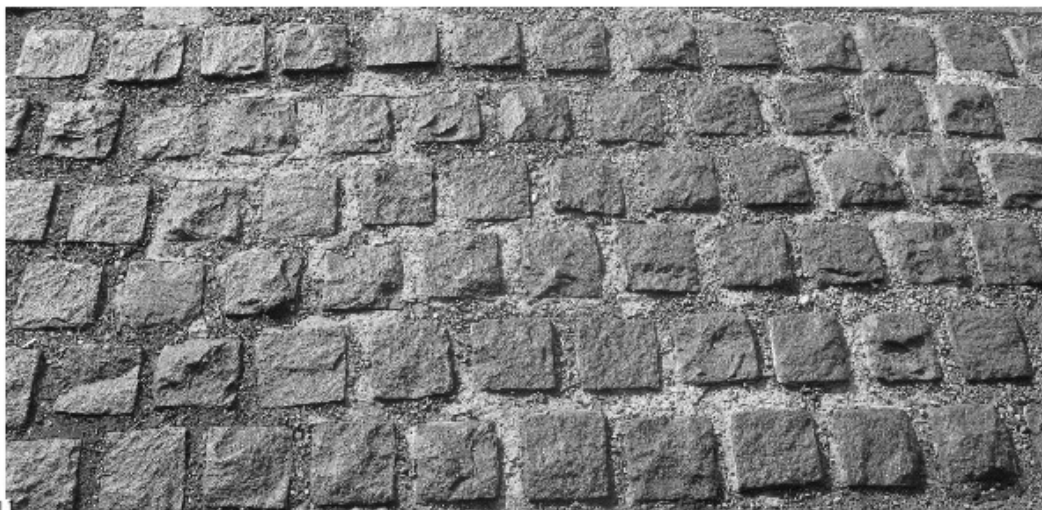
E15961

1. Typical road surface that can generate the 'rattle' sound.

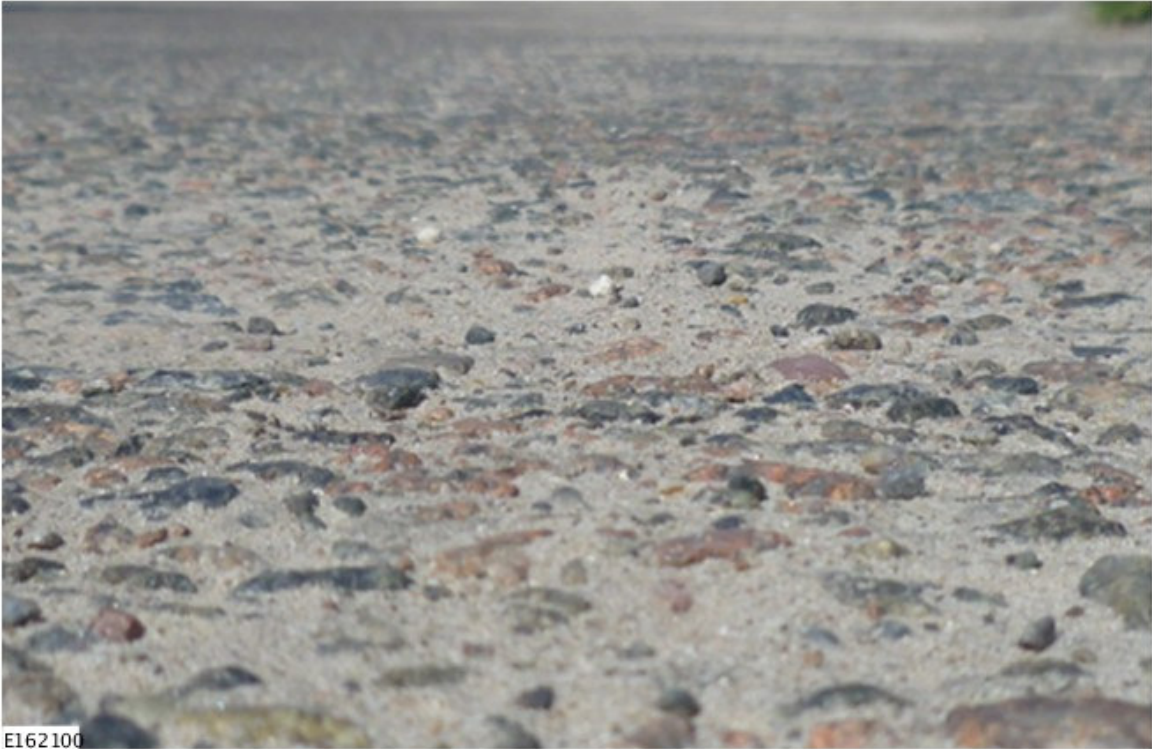
2. Typical road surface that can generate the 'rattle' sound.
