TECHNICAL BULLETIN  
LTB00648NAS1  
17 NOV 2014

**SECTION: 418-02**

Harness Repair Terminal Block C44-R2

**Range Rover (LG)**

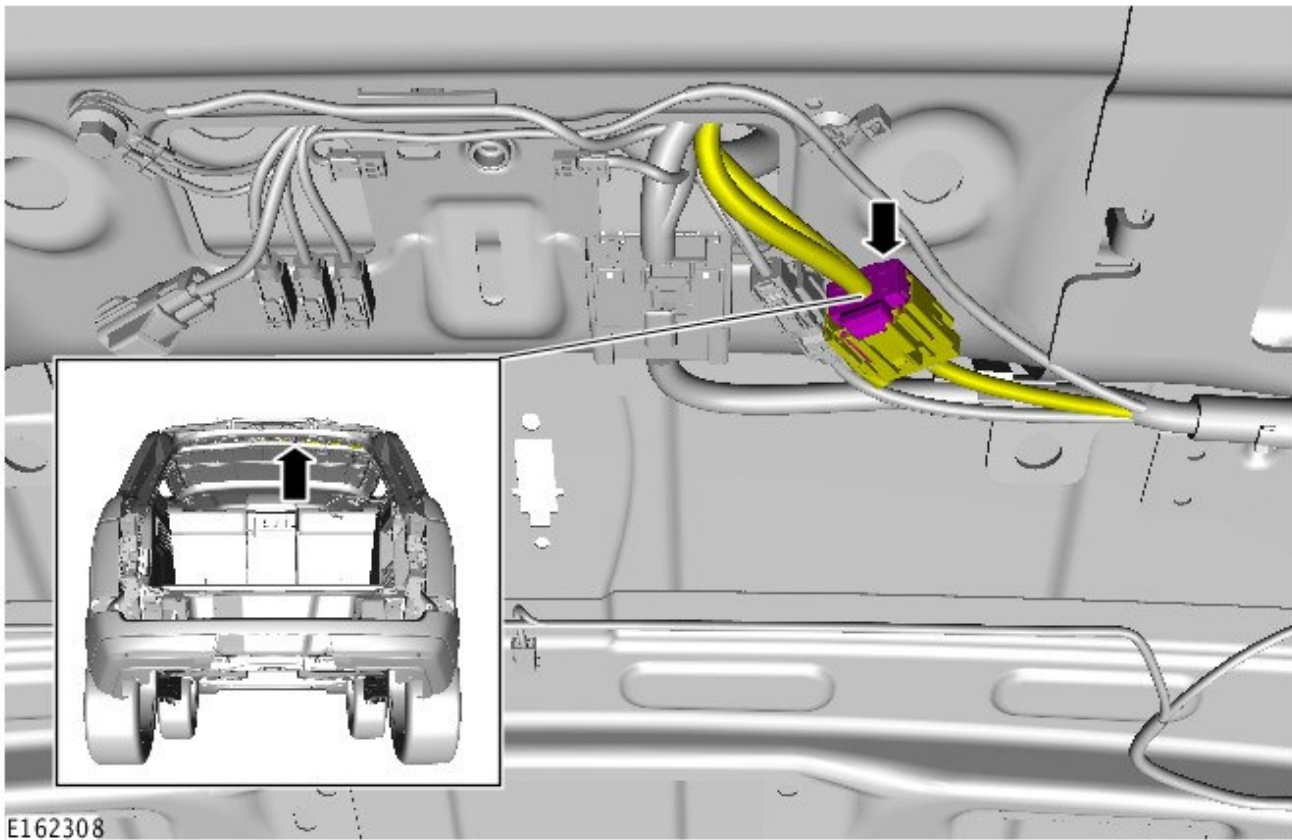
**Cause:** These may be caused by terminal block C44-R2 pins 10, 17, 18, and/or 21 having poor continuity.

**18.** Disconnect the electrical connector C44-R2 from C44-R1.

19. Remove the terminals in the positions 10, 17, 18, and 21 and carry out a pin drag test with each corresponding terminal of connector C44-R1.

- If any of the terminals show no sign of resistance to movement during the test, continue to step 20.
- If any of the terminals offer a small amount of resistance, refit the original terminals to connector C44-R2 and carry out a continuity test across the two connectors.
- If the joint has good continuity, continue with further diagnosis with reference to TOPIX and SDD.
