# Service Bulletin

Bulletin No.: PIT5304

**Subject:** Integrated Center Stack Display Delaminating Distorted Or Appears Cracked Behind Lens

**Models:** 2013-2014 Cadillac ATS, SRX, XTS  
2014 Cadillac CTS VIN A, ELR  
Equipped with Cadillac CUE 8 inch Touch Screen

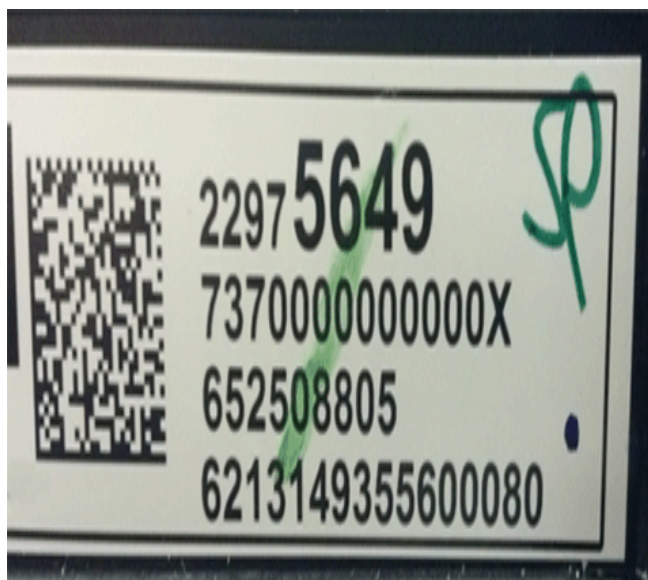
3957160

Please contact the GM Technical Assistance Center for Integrated Center Stack (ICS) replacement authorization. Please provide the part number (top line located on the part sticker) and the first 7 digits of the bottom line of the part sticker.
