Service Bulletin

Bulletin No.: PIT5312

Subject: Steering Column Grind Pop Bind Noise And/Or Feeling When Turning

Models: 2015 Cadillac Escalade Models
2014 Chevrolet Silverado 1500
2015 Chevrolet Silverado, Suburban, Tahoe
2014 GMC Sierra 1500
2015 GMC Sierra, Yukon Models
With Tilt and Telescoping Steering Column (RPO N38 or N37)
Built Before August 12, 2014

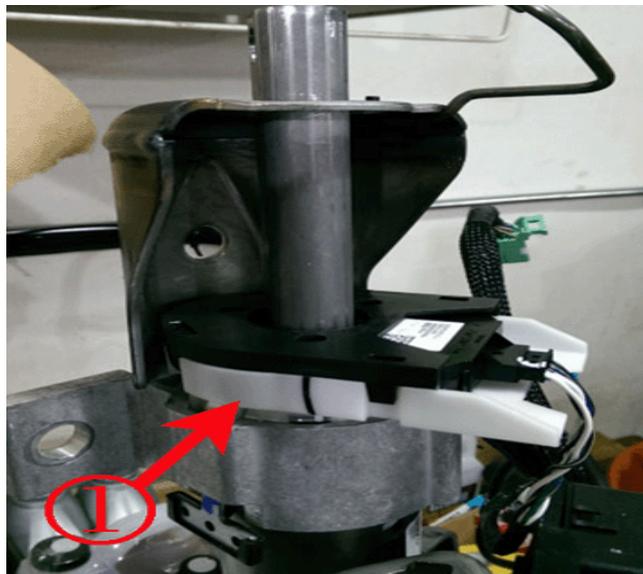
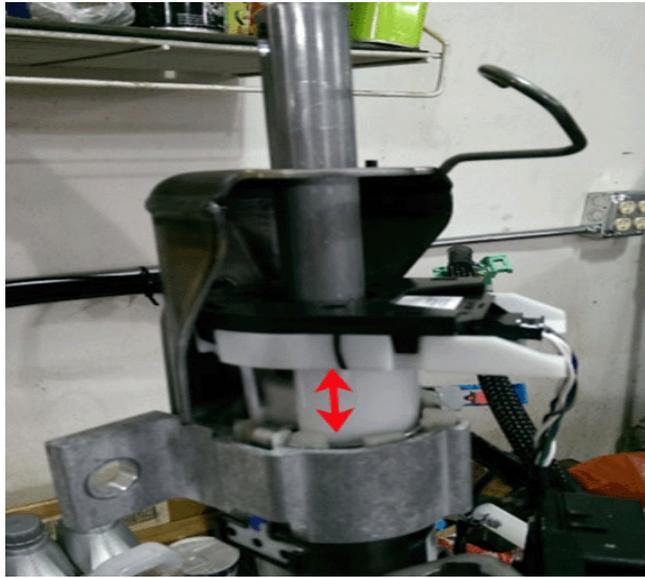
3924680

1. The lower column bearing (1) may be out of position. The 1st picture shows the lower column bearing (1) in its correct position, while the 2nd picture below shows the lower column bearing out of position.

Note: Do Not repair the steering column for these conditions.

Replace the steering column assembly to correct either condition

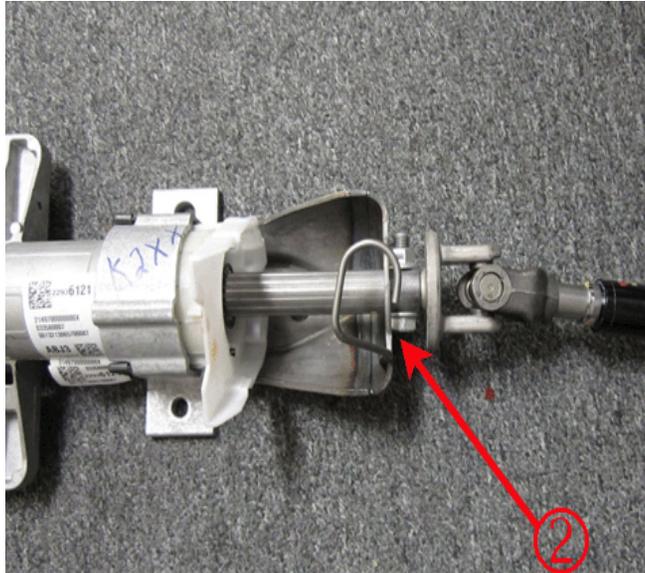
3924682

2. The upper intermediate steering shaft to lower column shaft bolt and nut (2) may be contacting the inhibitor/shiftier cable bracket, as shown below.
