Service Bulletin

Bulletin No.: PIT5351

Subject: Itch Squeak Type Noise From HUD Area

Models: 2015 Cadillac Escalade Models
2015 GMC Yukon Models
With Head-Up Display (RPO UV6)

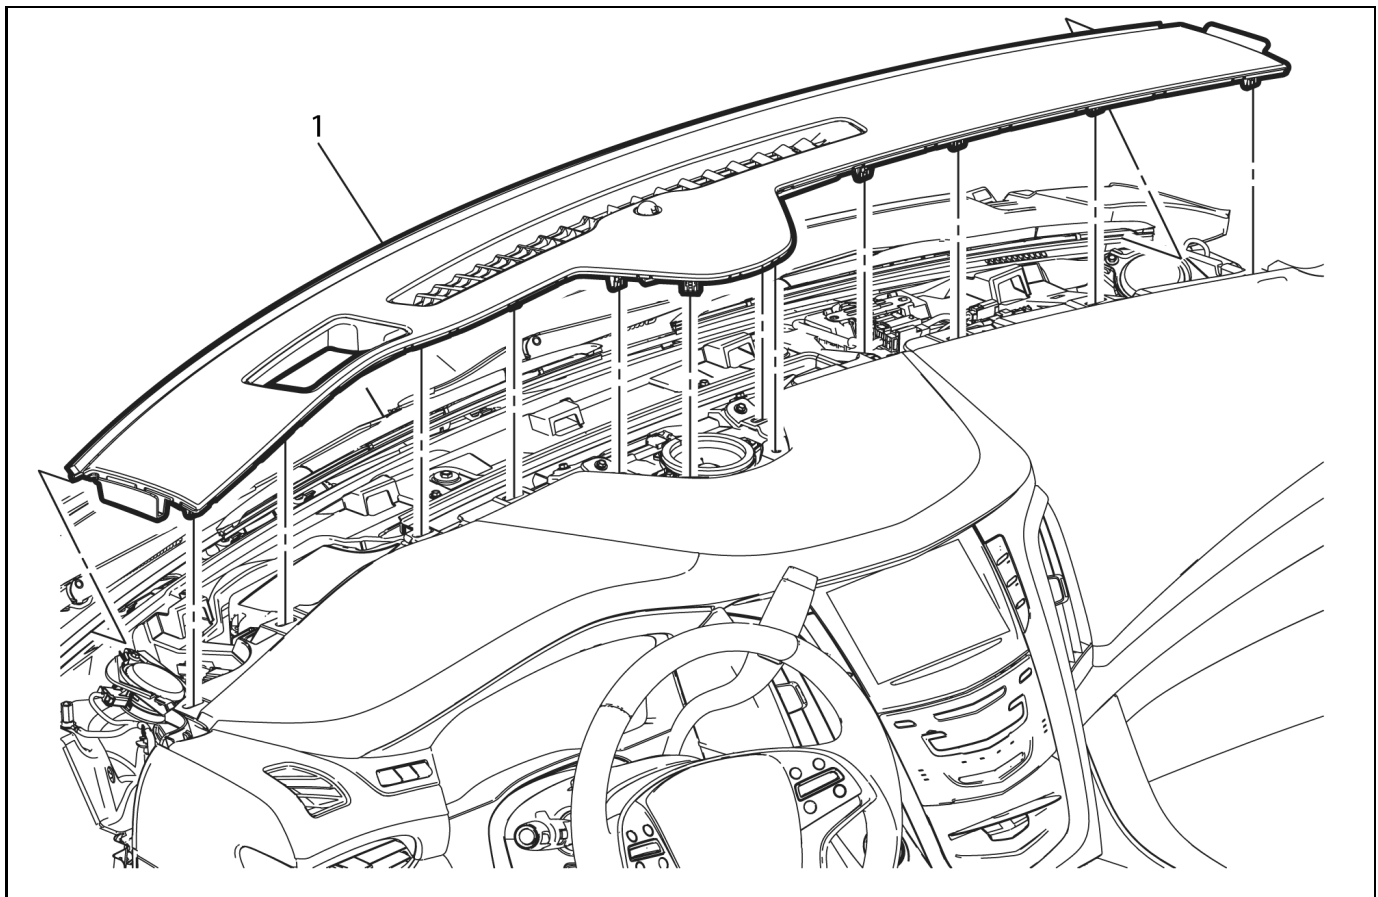
3621783

The noise could be caused by the Heads-Up Display (HUD) lense rubbing on the HUD shroud. The HUD shroud is part of the Upper Instrument Panel Extension, as shown below.

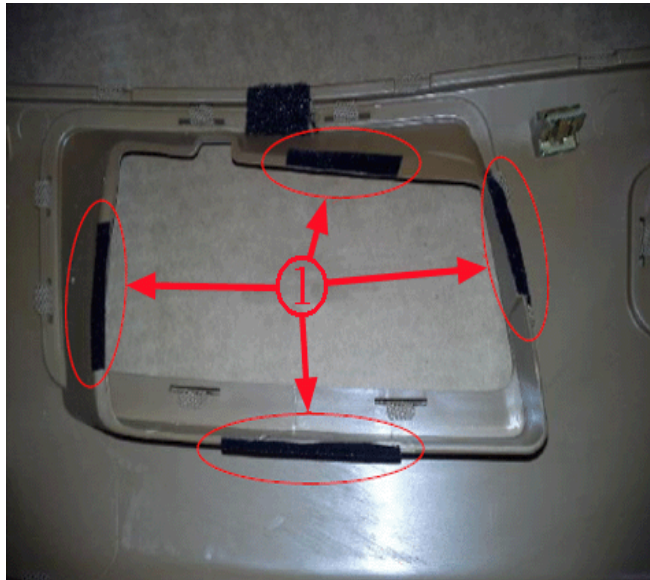
4009586

The HUD shroud may have four areas with felt tape (1), as shown below, which is inadequate to eliminate this noise.
