Service Bulletin

Bulletin No.: PIT5359

Subject: Radio Back Lighting Stays On After Key Off / Dead Battery / TCCM Repeat Failure

Models: 2014 Chevrolet Silverado 1500
2015 Chevrolet Silverado
2014 GMC Sierra 1500
2015 GMC Sierra
With Transfer Case (RPO NQF or NQH)

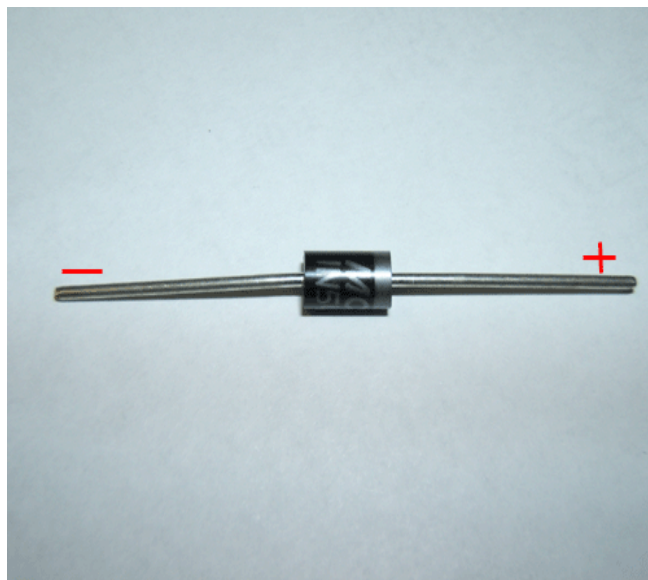
To prevent damage to any of the sensitive electronic components on the bussed circuit, the solenoid/relay MUST have the control circuit suppressed with a diode. The diode will prevent the voltage spikes from being transmitted onto the Run/Crank circuit.

Install a diode, P/N 12112422, across the coil of the solenoid. It is important that the striped end of the diode be connected to the positive terminal of the coil and the other end of the diode be connected to ground.

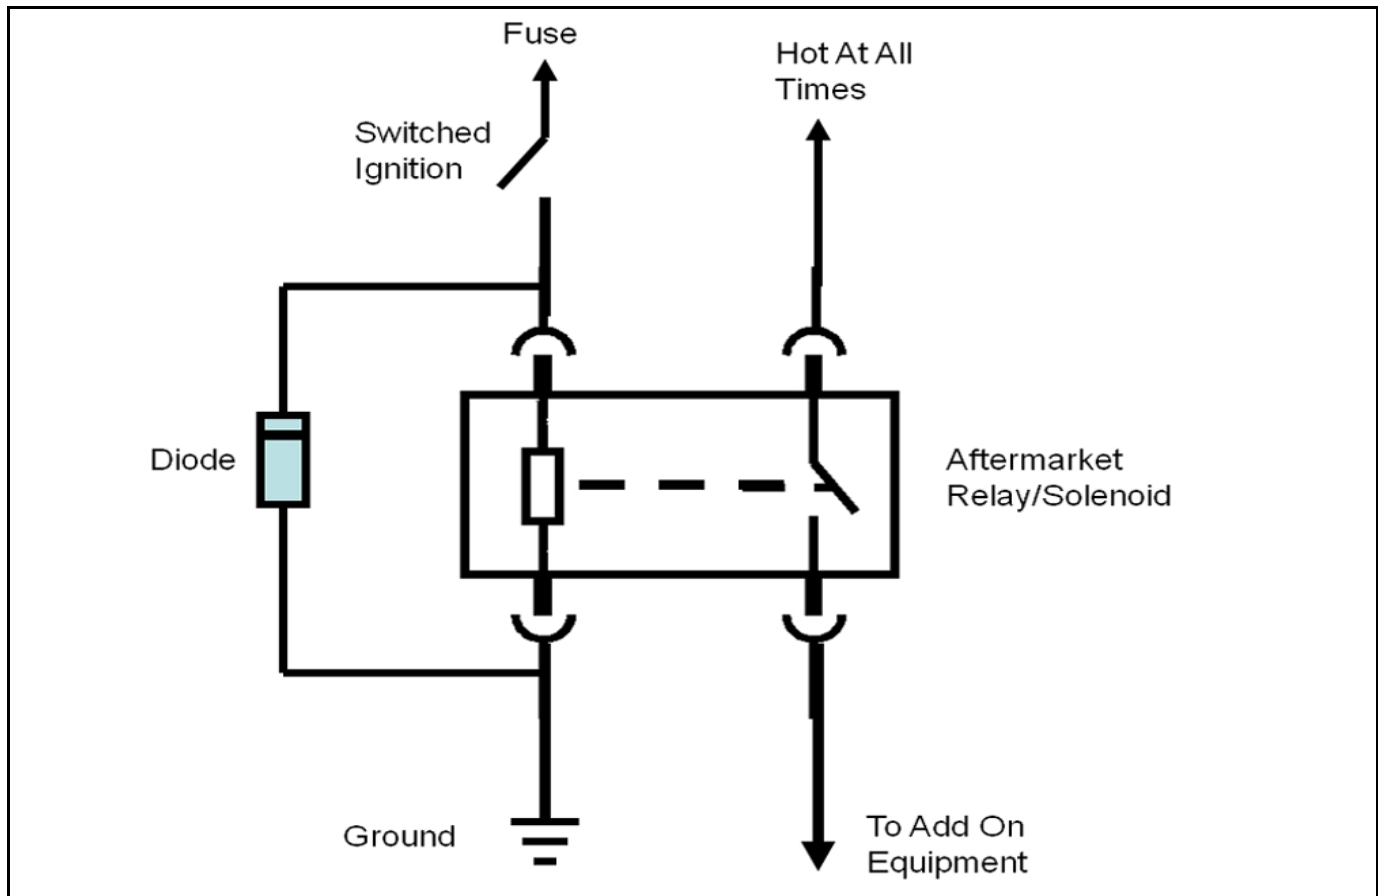
2226201

Notice: Some solenoids/relays may only have a positive post and will get their ground through their mounting bracket. In this case, the striped end of the diode is to be connected to the positive terminal and other end should be connected to the ground of the solenoid/relay.

Install a diode, P/N 12112422, across the coil of the relay. It is important that the striped end of the diode be connected to the positive terminal of the coil and the other end of the diode be connected to ground. Be sure to insulate the diode with heat shrink tubing before installing.
