Service Bulletin

Bulletin No.: PI1262

Subject: Noise Heard from Center Console

Models: 2014 Chevrolet Silverado 1500
2014 GMC Sierra 1500

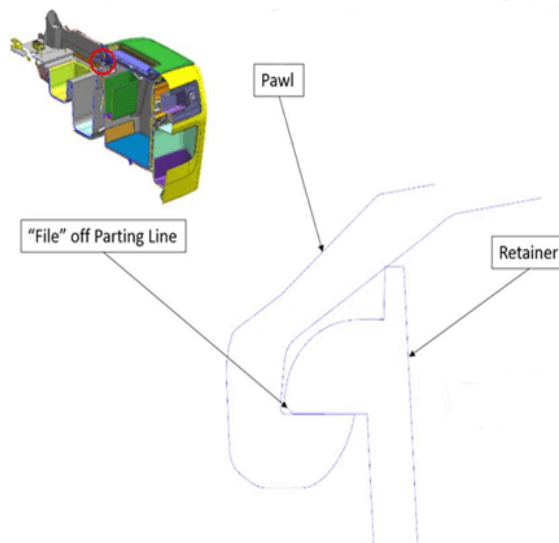
3925866

Some customers may comment on a noise heard from the center console.
This condition may be caused by a plastic burr on the center console retainer.

Modify the retainer using a file to remove the parting line as shown in the illustration above.
