Service Bulletin

Subject: Diagnostic Tip for Unable to Remove DC Vehicle Plug from Charge Port After Charging is Complete or Successfully Stopped, DTC P3014 Set

Models: 2014 Chevrolet Spark EV Condition/Concern

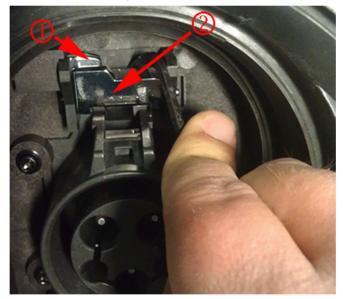
3824196

This condition may be caused by the DC charge port lock being stuck closed when the DC vehicle plug is engaged.

If the DC vehicle plug cannot be disconnected from the charge port due to the lock being stuck, perform the following steps to release the plug. Once the DC vehicle plug has been removed, the receptacle will need to be replaced.

- 1. Using the short end of a small allen wrench, push in the actuator rod located behind the latch.
- 2. Apply a minimum of $45 \text{ N} \cdot \text{m}(10 \text{ lb})$ of force to the actuator rod.
