Service Bulletin

Bulletin No.: P11281

Subject: Sliding Door Does Not Stay Open While Vehicle is on a Downslope and/or Sliding Door Closes too Easily

Models: 2014 Chevrolet Express
2014 GMC Savana
Vehicles Built Prior to June 26, 2014

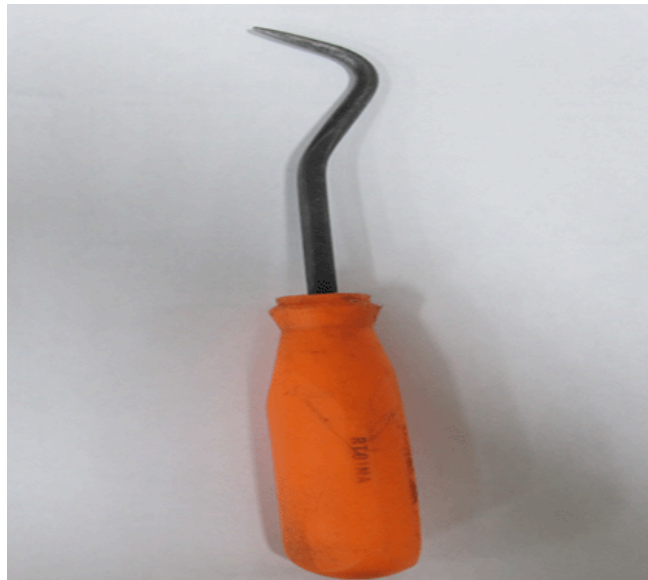
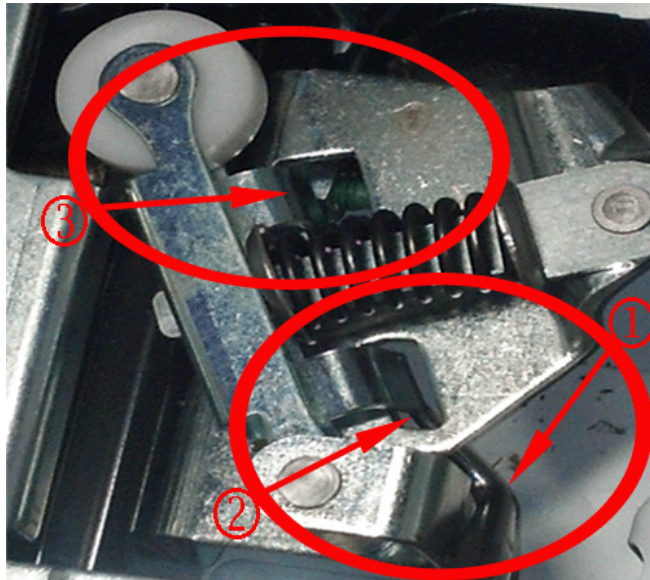
This condition may be due to the position of the roller arm not holding the sliding door in the open position.

- Use a pick tool and place under the base plate of the checker (1) and hook the tab (2) while bending inboard. Ensure the tab that is closest to the roller is now touching the trim edge (3) of the window with no gap as shown in the illustrations above.
