# Service Bulletin

Bulletin No.: P11282

**Subject:** Shift to Park Message Displayed in Drivers Information Center (DIC) When Vehicle is Shut Off

**Models:** 2014 Chevrolet Corvette  
Equipped with Automatic Transmission (RPO MYC)

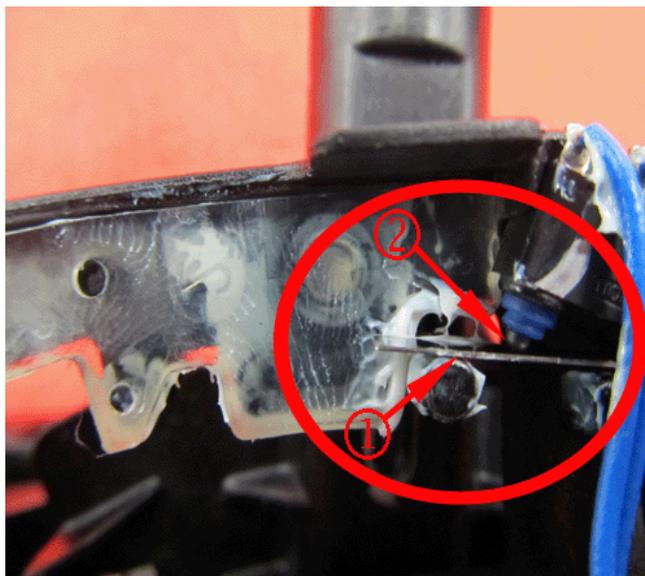
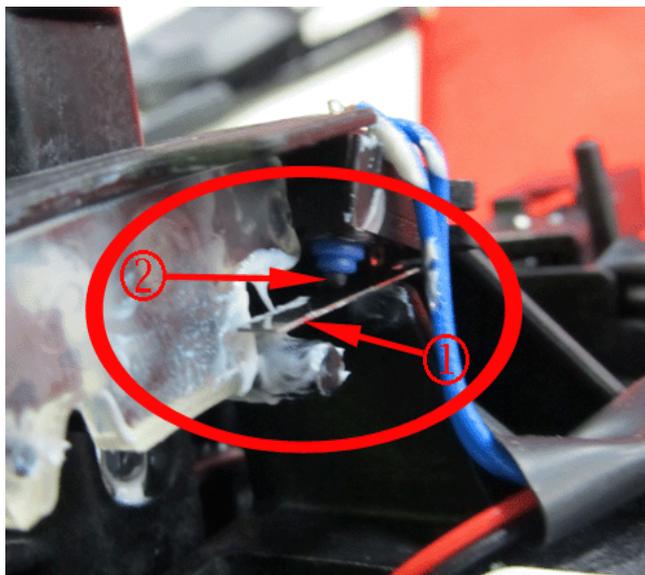
This condition may be caused by the shifter detent spring (1) being misadjusted, causing the shifter to not close the Park switch (2) as shown in the illustrations above.

Follow the procedure below for inspecting and/or adjusting the shifter spring detent and Park switch.
